CONTAMINATED LAND RISK ASSESSMENT

***PHASE 1 DESK TOP STUDY
& PRELIMINARY SITE INVESTIGATION***

**Aldcliffe Road Triangle
Lancaster**

Date: 8th April 2013

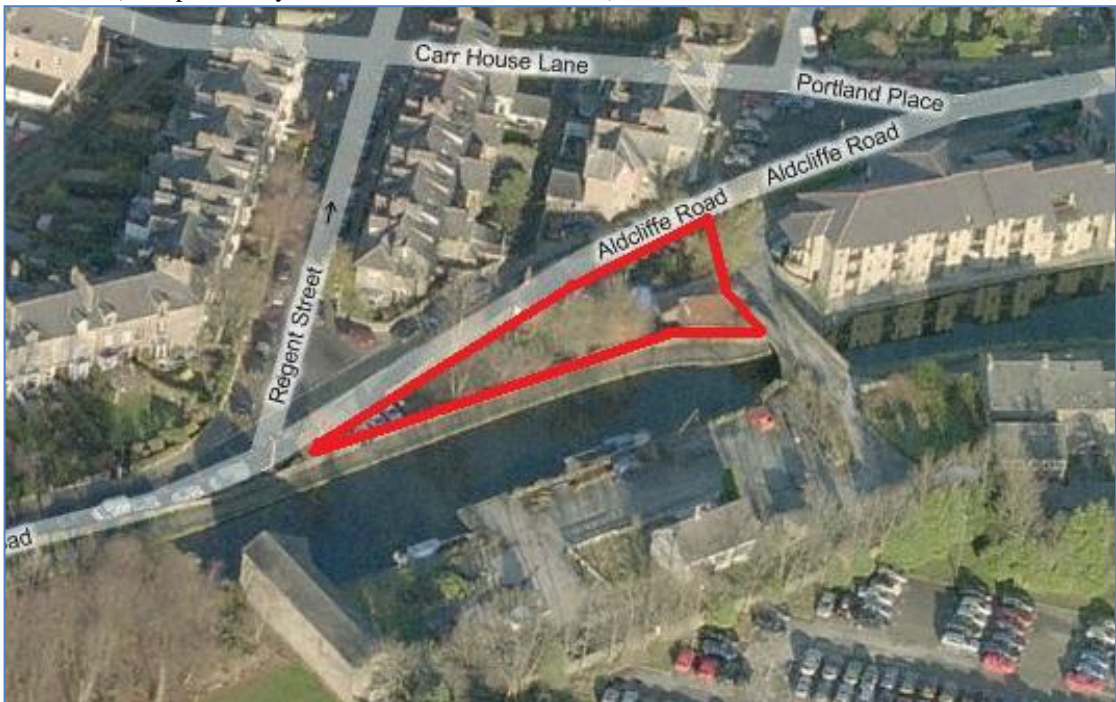
Photo 1. (This photo may be several months out of date)

The site assessed for this investigation currently comprises 759 m² of land located on Aldcliffe Road, Lancaster. Roads bound the site to the north, east and west, with a canal to the south (Photo 1). A grassed area of land with trees and storage buildings are located on the site. The land on and surrounding the site slopes down to the south and west.

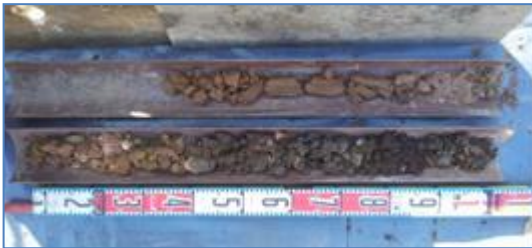
Photo 6. (View at BH3)

Potential contaminant concentrations in BH3 were all within guideline values for a residential and commercial property.

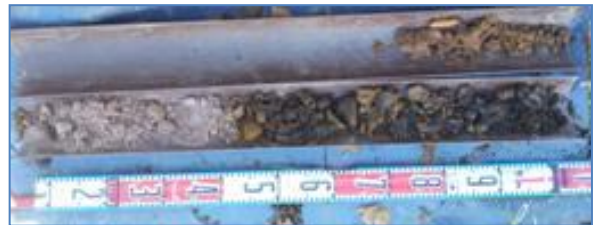
Photo 7. (View at BH4)

The site is considered to pose no risk to controlled waters as no evidence of contamination was evident within the natural ground. The clay soils would help restrict pathways of elevated concentrations of PAH's encountered at BH 4.

1) Removal of 0.6 m bgl of ground within a 1 m radius in the areas around BH 1, BH 2 and BH4. Imported topsoil should be in accordance with BS3882 and placed over a no dig geotextile barrier in the proposed landscaped areas.

2) A no dig barrier is installed into the areas around BH1, BH2 and BH4 and covered with an imported topsoil within raised beds.
