## Summary – Fences survey, January-February 2026

This report describes the fence survey carried out in January and February 2026. It describes the types of fences on the nature reserve, explains the assessment criteria for the survey, identifies the gates and fences in need of repair, and makes further recommendations.

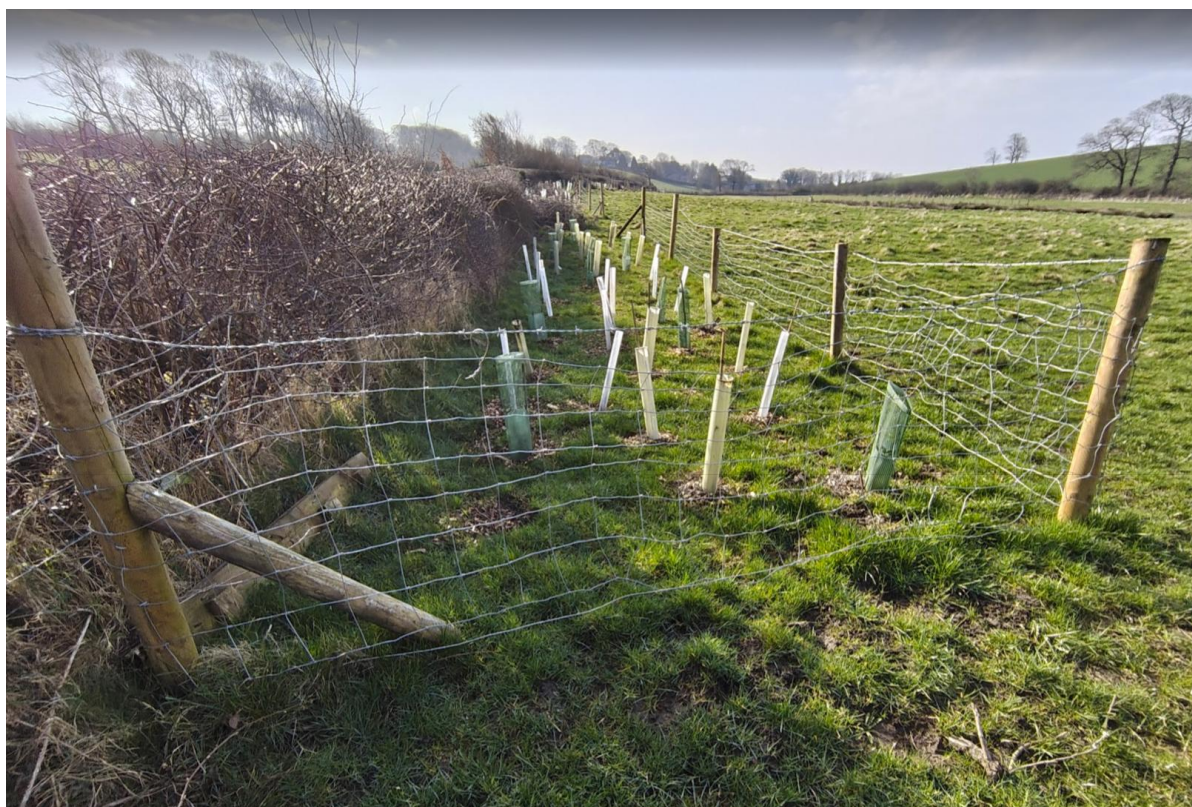
Figure 3 – Example of a strut, and insufficient tensioning in a fence without strainer posts

- There is a mixture of P-W fencing, with the original fences constructed by contractors compliant with best practice, and several P-W fences constructed by volunteers, that do not comply with best practice. For example, there is a lack of strainer posts and sufficient tensioning - in simple terms, these are questionably stock-proof (Figure 3 and Item 26 in Annex A of this report show examples). A small number of volunteers have attempted to remedy this by encouraging the use of fence posts as makeshift struts for corner posts, but this is a poor substitute for strainer posts and struts that represent best practice (Figure 3, left side).

- Many of the non-compliant P-W fences have suffered from damage by cattle, whilst some of the compliant P-W fences have lost some tension, which typically happens over several years after cattle lean on the fence posts.

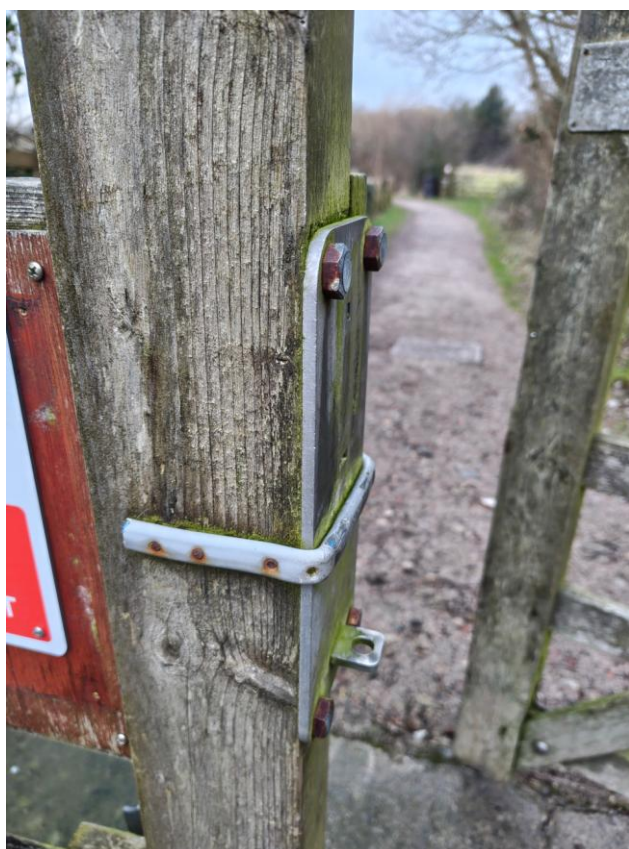
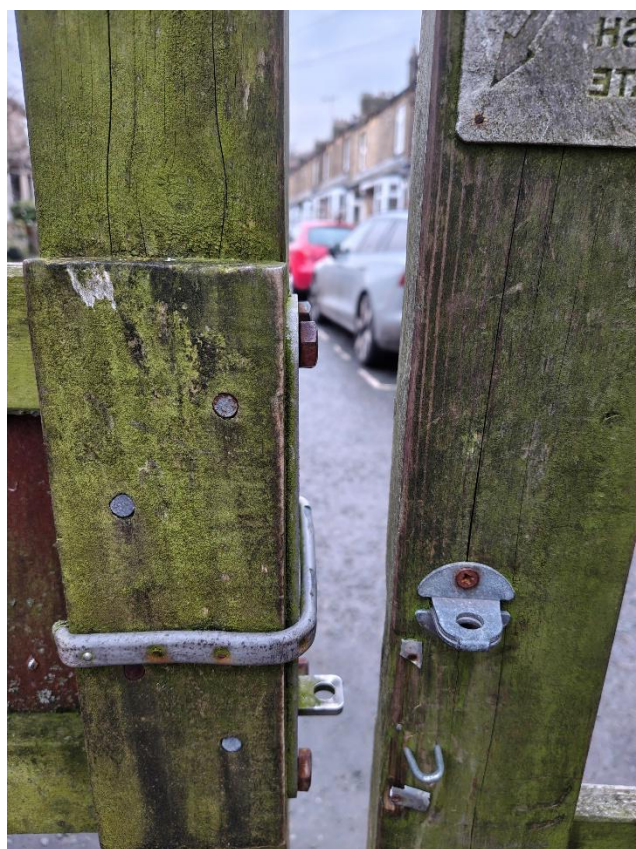
| Item | 0 |

| Location | Cromwell Road, entrance |
| Category | <b>Amber</b> |
| Observations | Missing hasp, unable to lock. A lock is needed to control vehicular access. |

| Recommendations | Fit a strong latch and padlock. |

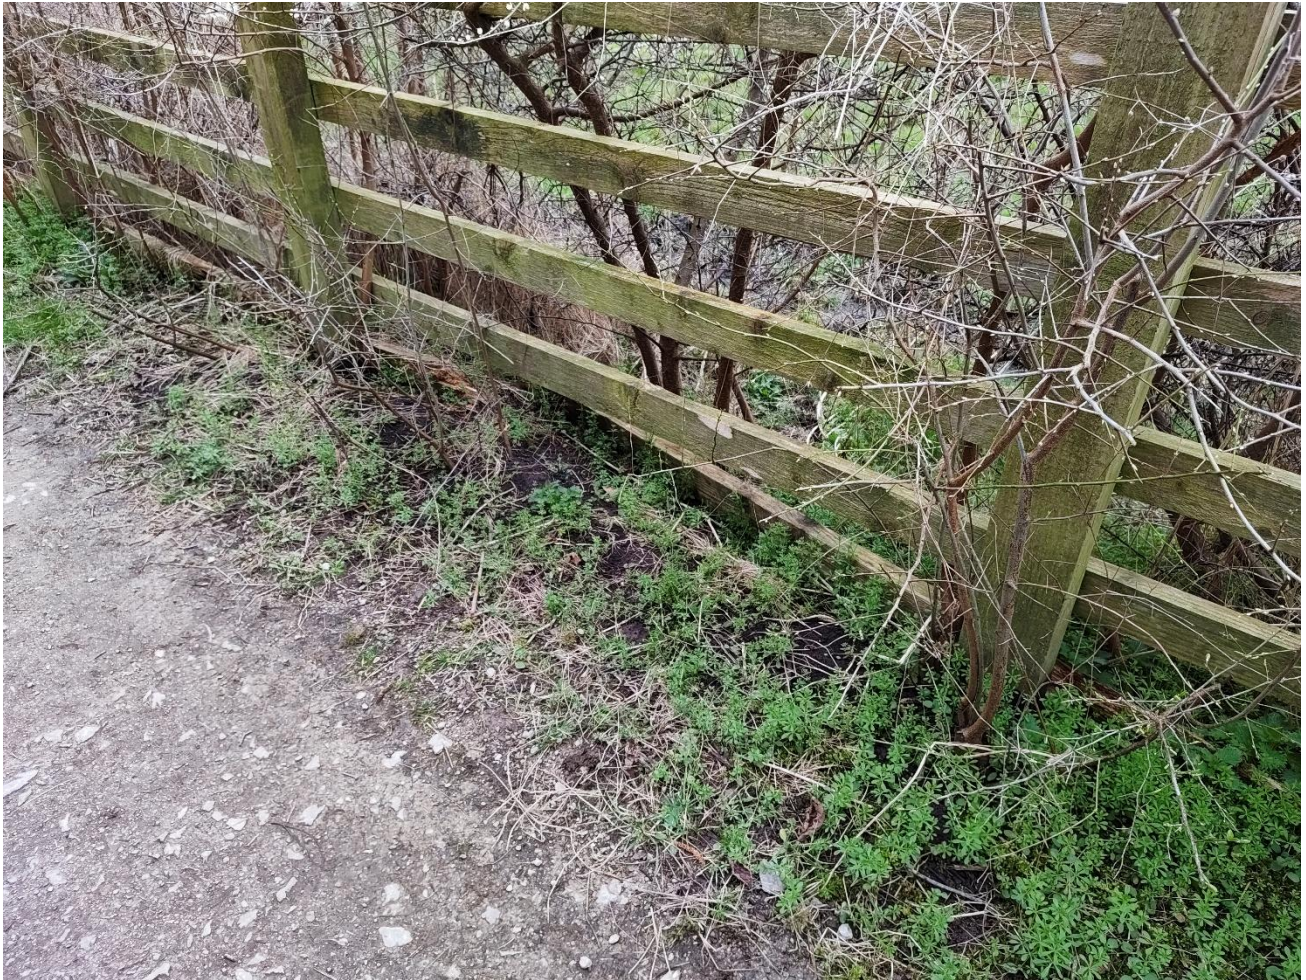
| Item | 1 |

| Location | Hay Meadow |
| Category | Red |
| Observations | Bottom rail rotten and displaced. |

| Recommendations | Replace and repair. |

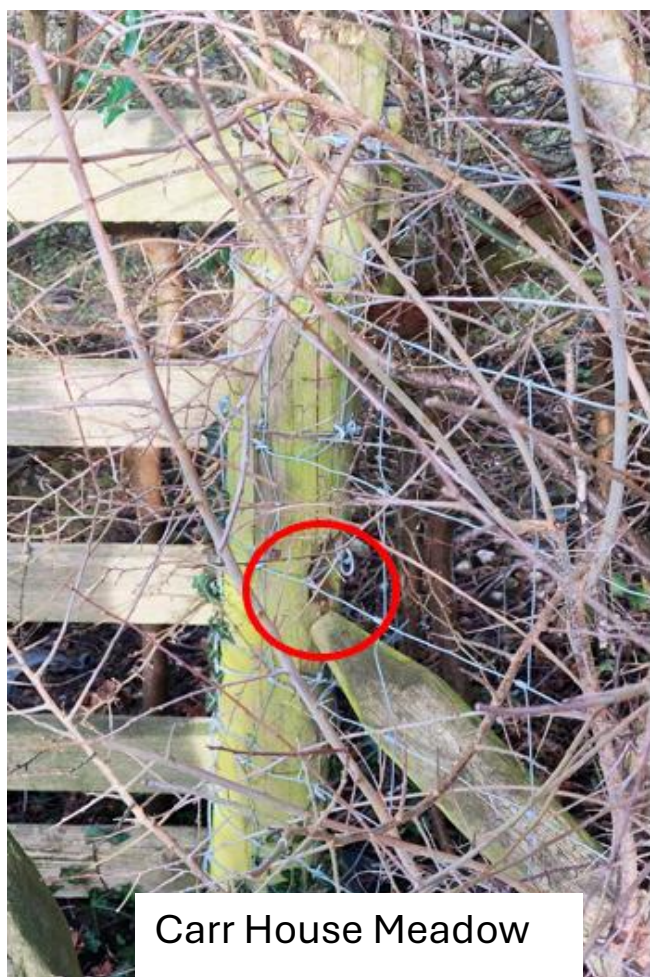
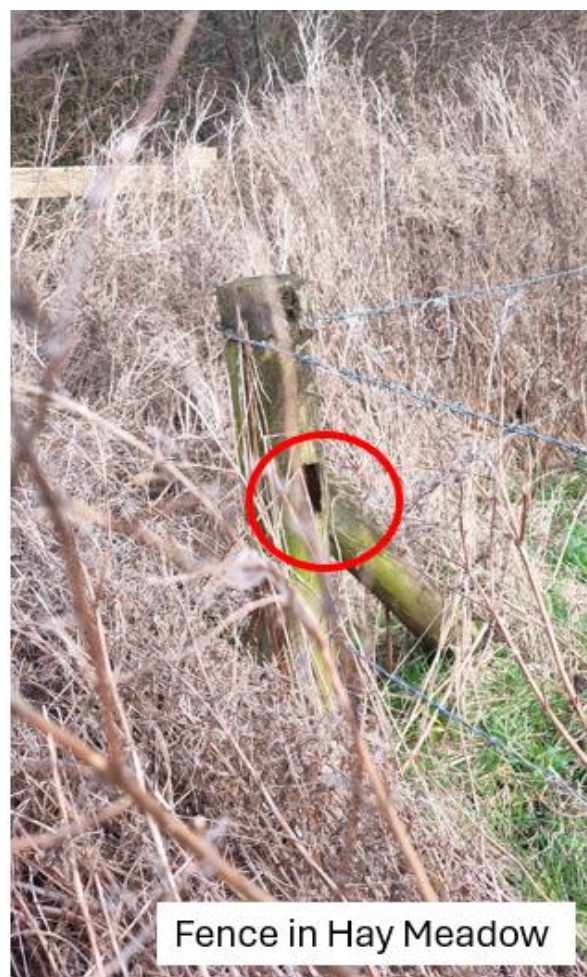
| Item | 2 |

| Location | Carr House Meadow <sup>1</sup> ; and opposite P-W fence corner in Hay Meadow |
| Category | <b>Amber</b> |
| Observations | Rotting strainer post, and ajar strut on P-W fence on RHS of footpath from Cromwell Road; missing strut on strainer post in P-W fence in Hay Meadow. |

| Recommendations | Schedule repair or replacements. |

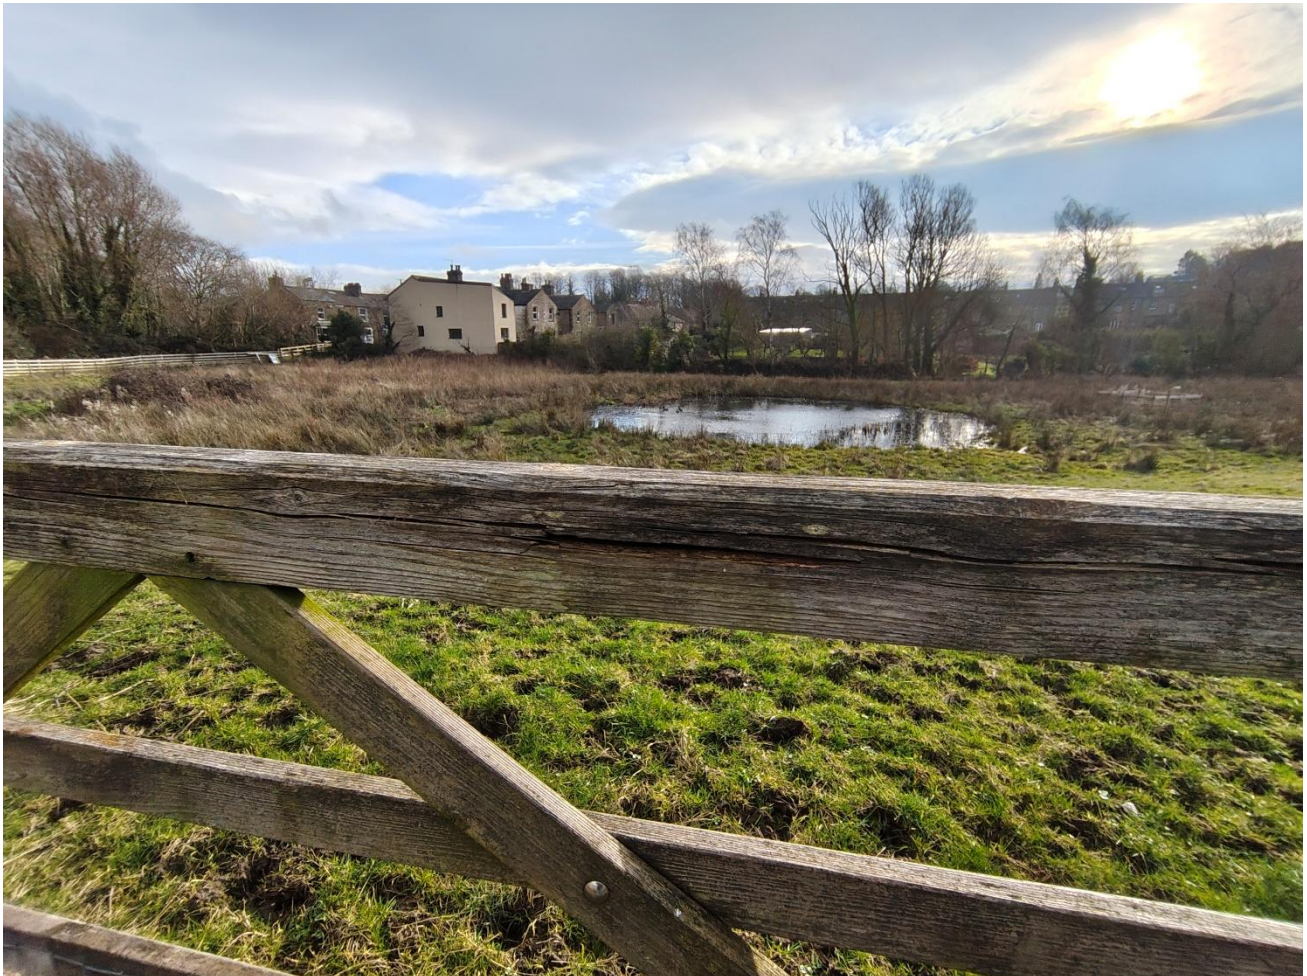
| Item | 3 |

| Location | Hay Meadow |
| Category | <b>Amber</b> |
| Observations | Top rail of gate overlooking the pond is rotting, with loss of structural integrity. |

| Recommendations | Schedule repair or replacement of rotten rail. |

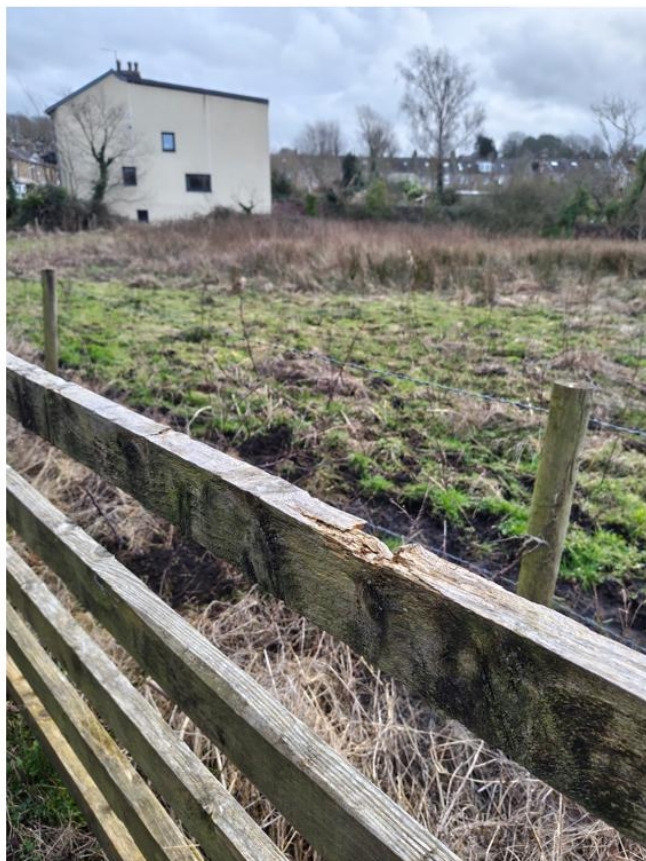
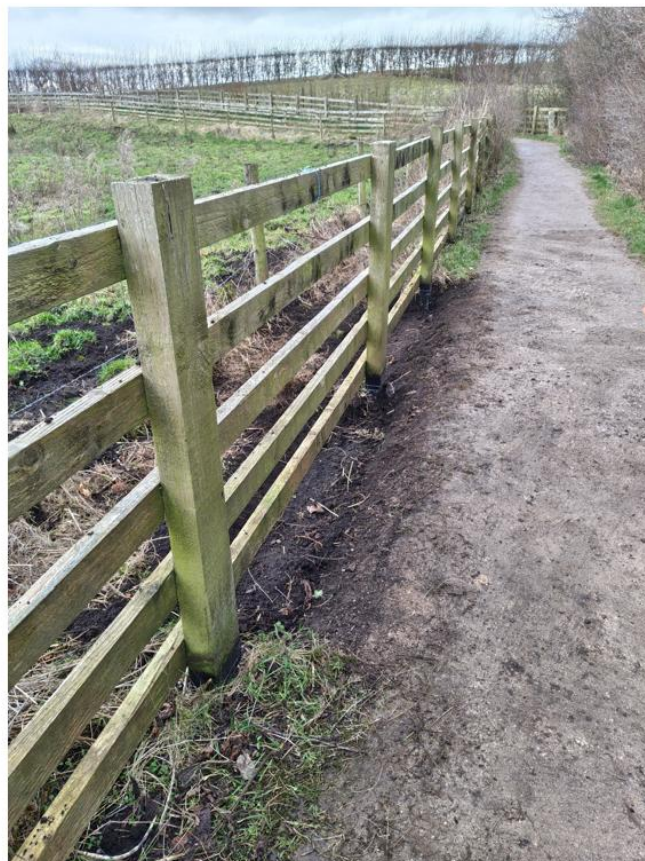
| Item | 4 |

| Location | Hay Meadow |
| Category | Red |
| Observations | Top rails, and some intermediate rails, are rotting and splitting, with significant loss of structural integrity. |

| Recommendations | Replace rotten rails. |

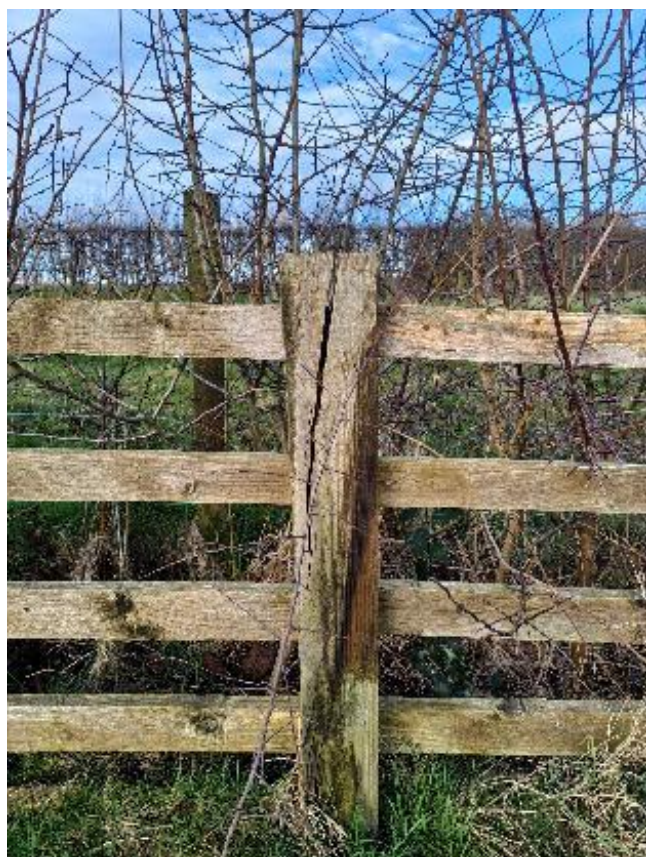
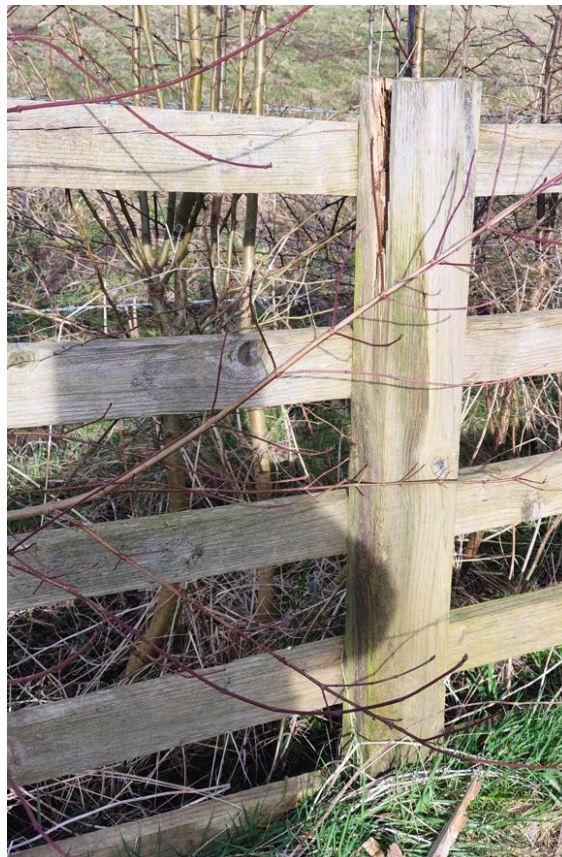
| Item | 5 |

| Location | Carr House Meadow |
| Category | Red |
| Observations | Posts rotting and split, leading to a loss of structural integrity |

| Recommendations | Replace |

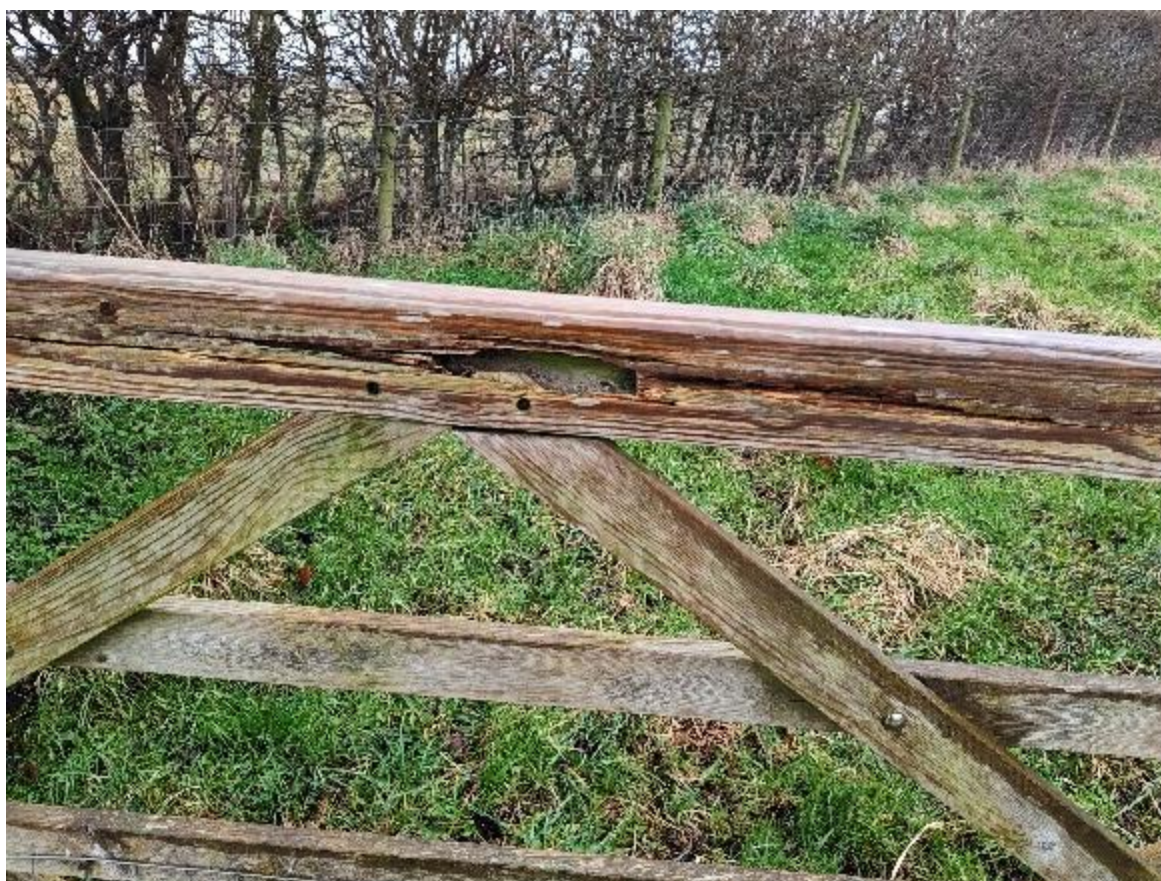
| Item | 6 |

| Location | Carr House Meadow, second upper gate |
| Category | <b>Red</b> |
| Observations | Top rail is rotting and at risk of losing integrity. |

| Recommendations | Replace the top rail. |

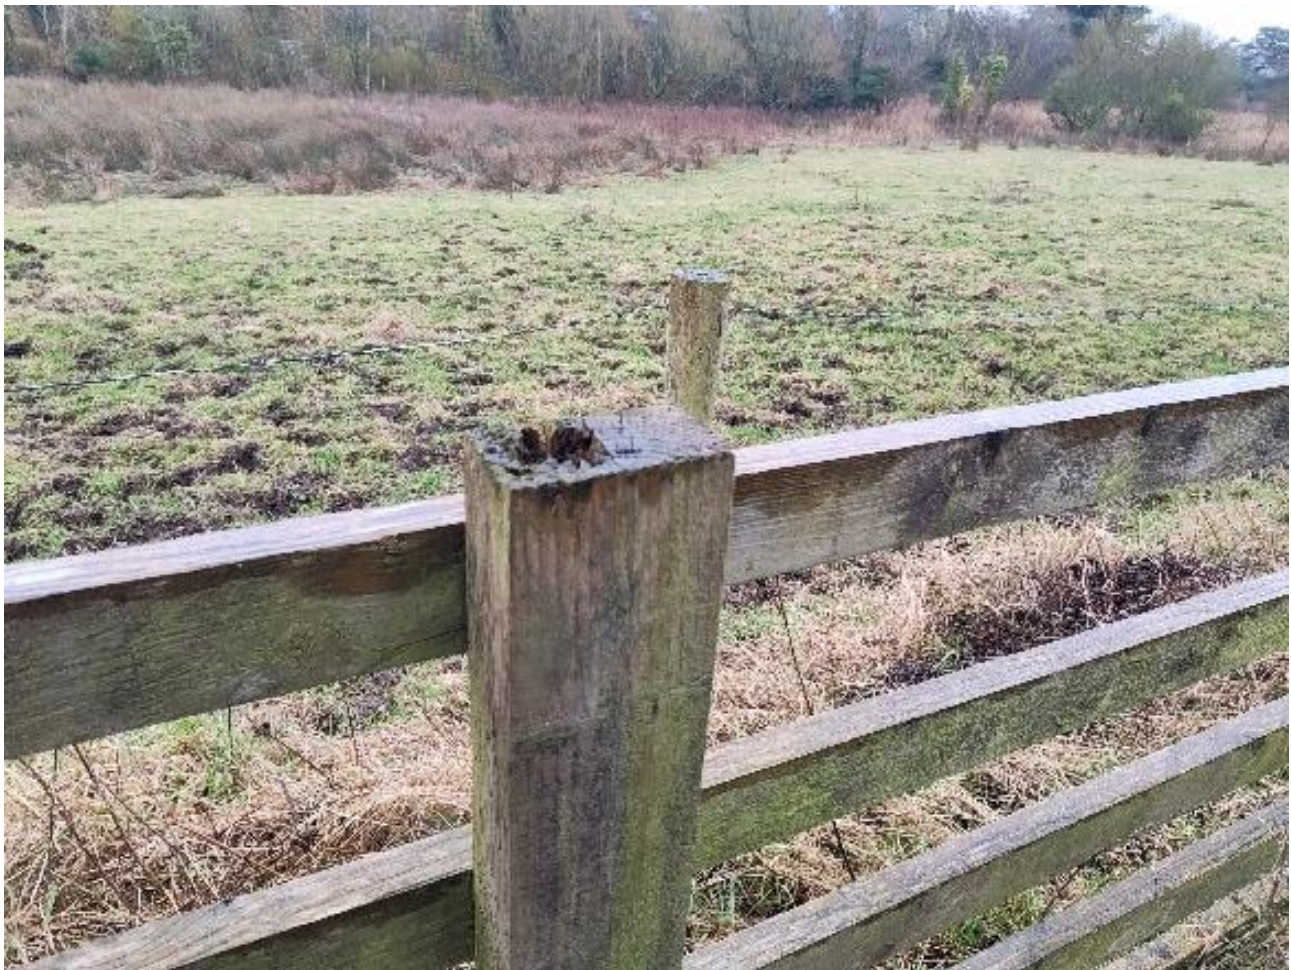
| Item | 7 |

| Location | Hay Meadow |
| Category | <b>Red</b> |
| Observations | The top of this post, and at least 10x others like it, are rotting and place the fence at risk of losing the top rail and losing integrity. |

| Recommendations | Trim and repair. |

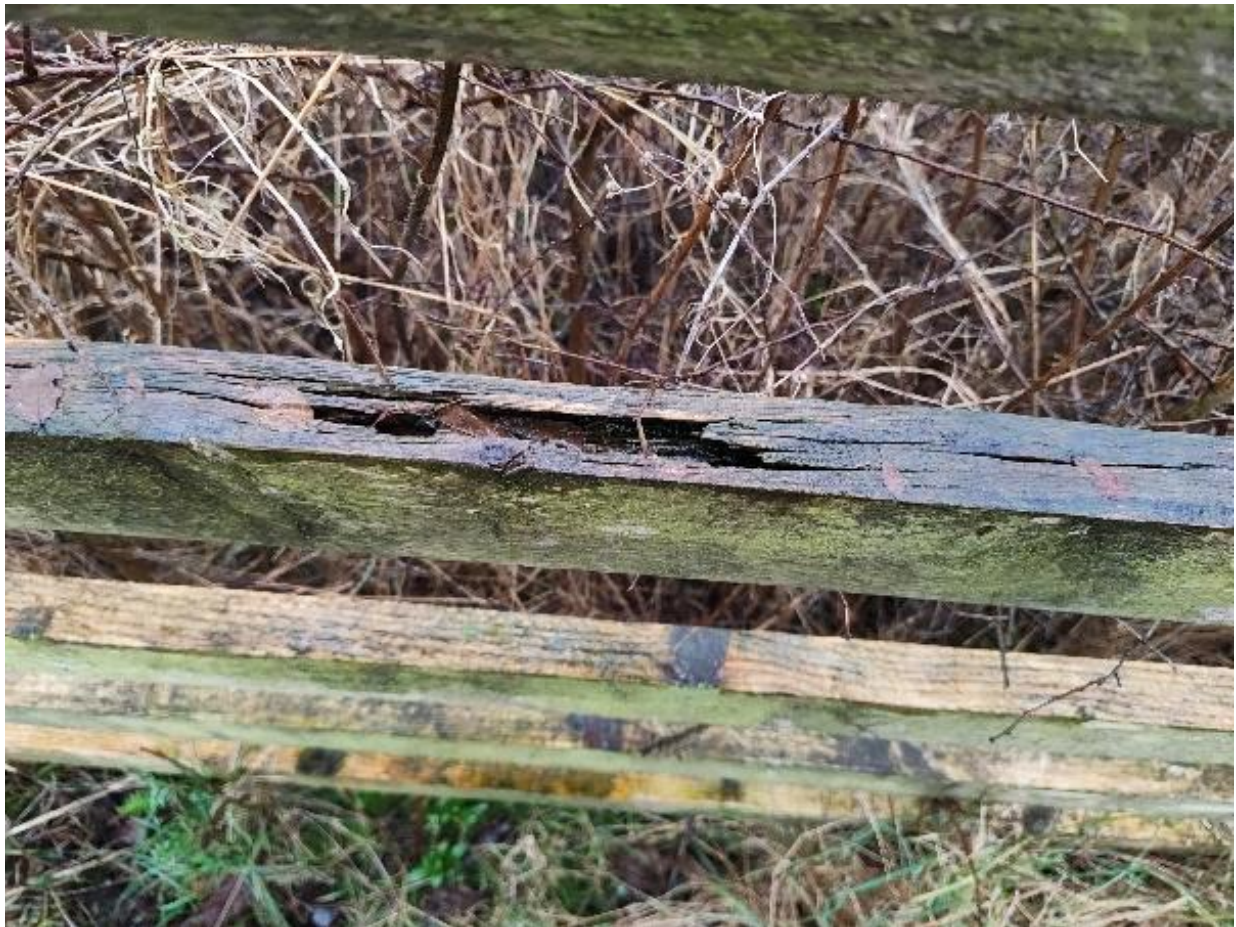
| Item | 8 |

| Location | Hay Meadow |
| Category | Red |
| Observations | Intermediate rail is rotting and placing fence at risk of losing integrity. |

| Recommendations | Replace |

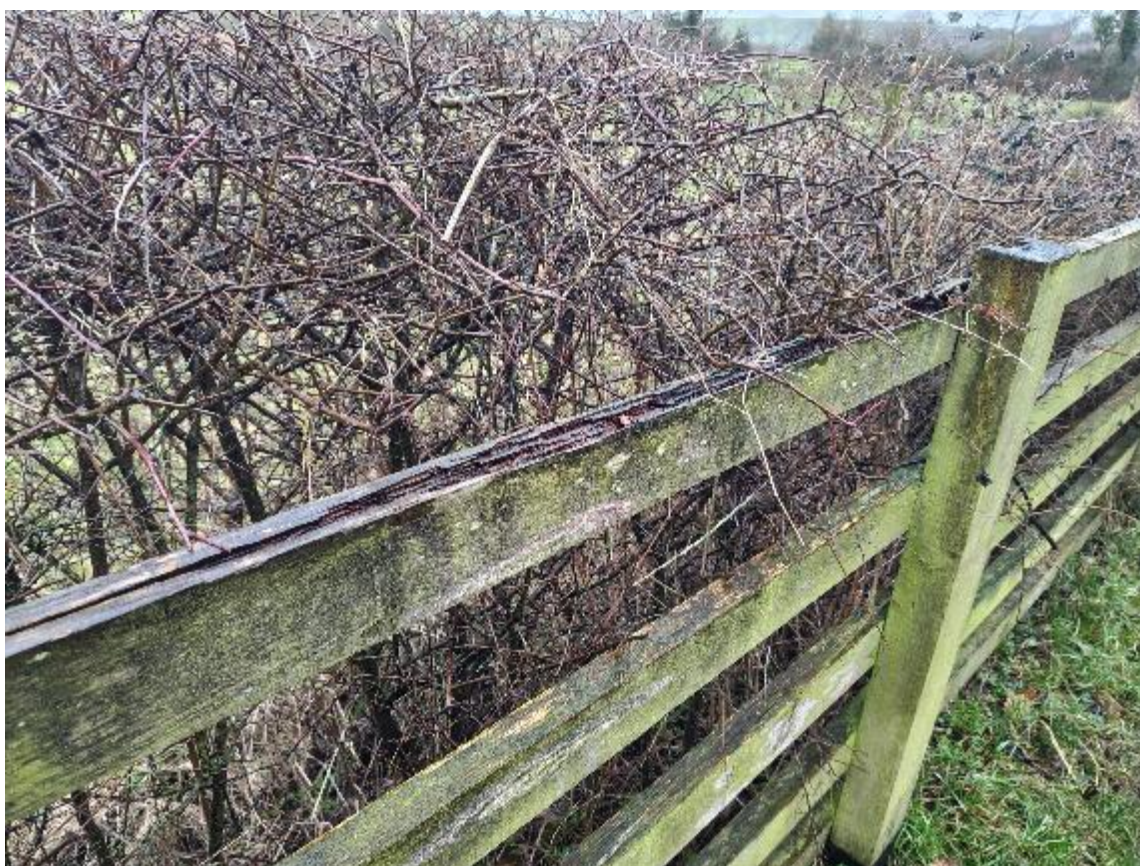
| Item | 9 |

| Location | Hay Meadow |
| Category | <b>Red</b> |
| Observations | Top rail is rotting and placing fence at risk of losing integrity. |

| Recommendations | Replace and repair. |

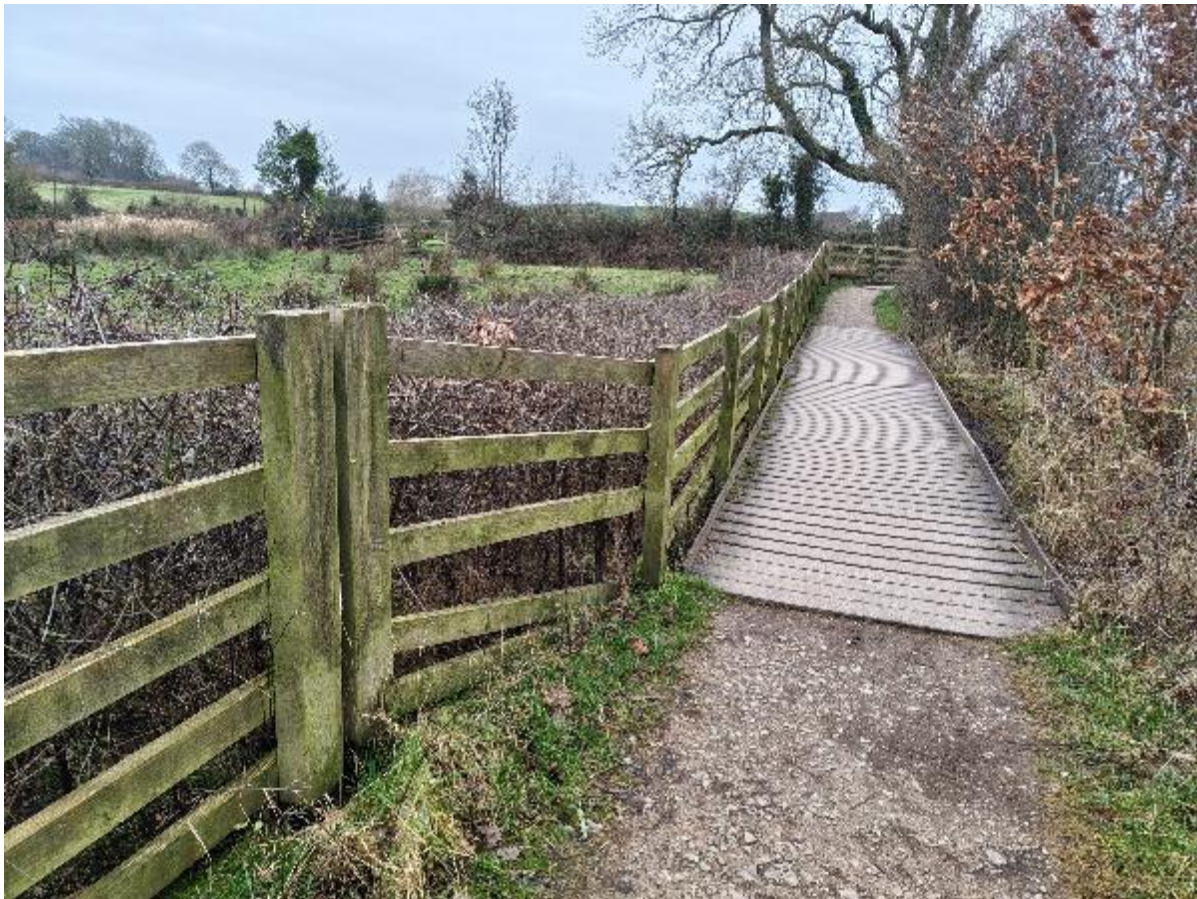
| Item | 10 |

| Location | Hay Meadow |
| Category | <b>Red</b> |
| Observations | Intermediate rail is rotting at end and fallen from post, and placing fence at risk of losing integrity. |

| Recommendations | Replace and repair. |

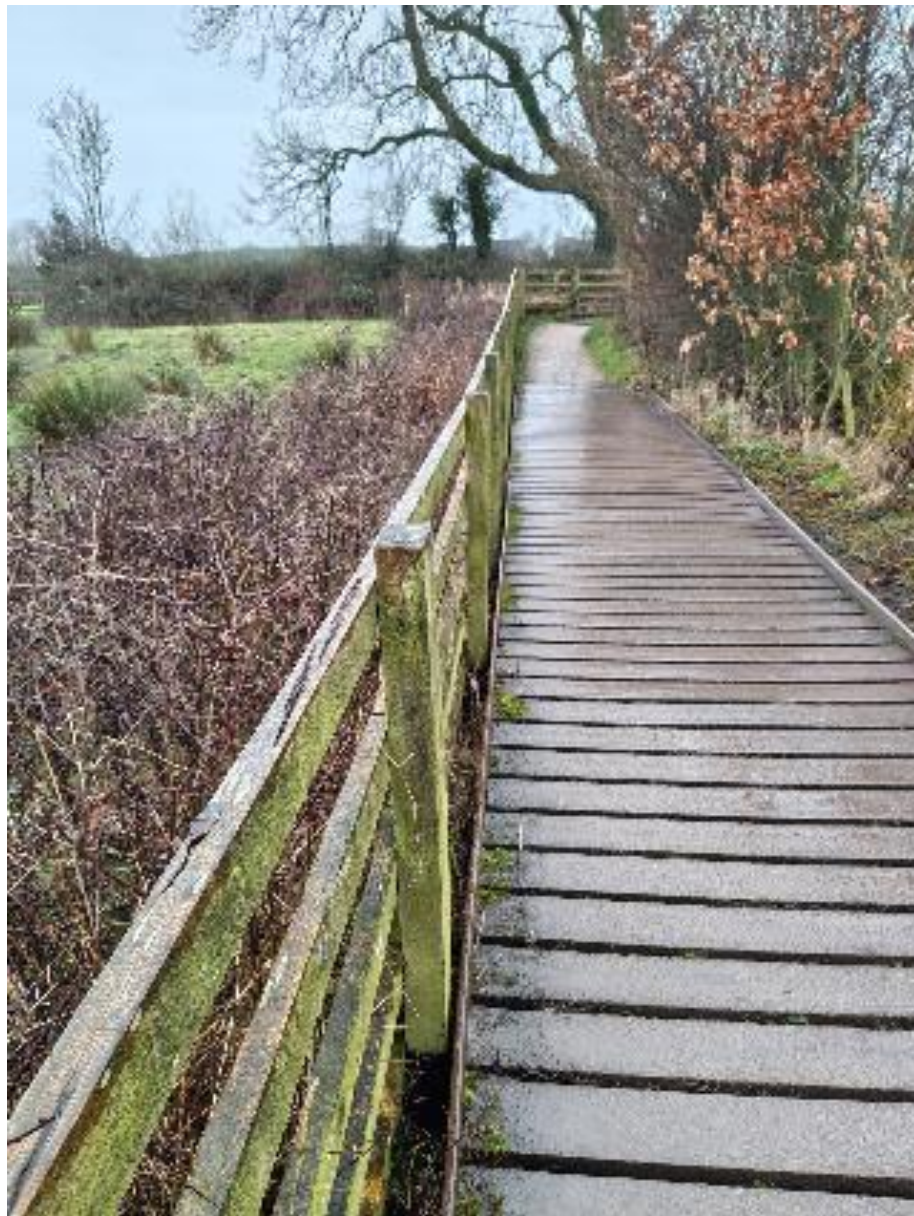
| Item | 11 |

| Location | Boardwalk, Big Meadow side |
| Category | Red |
| Observations | Top rail is rotting and placing fence at risk of losing integrity. |

| Recommendations | Replace and repair. |

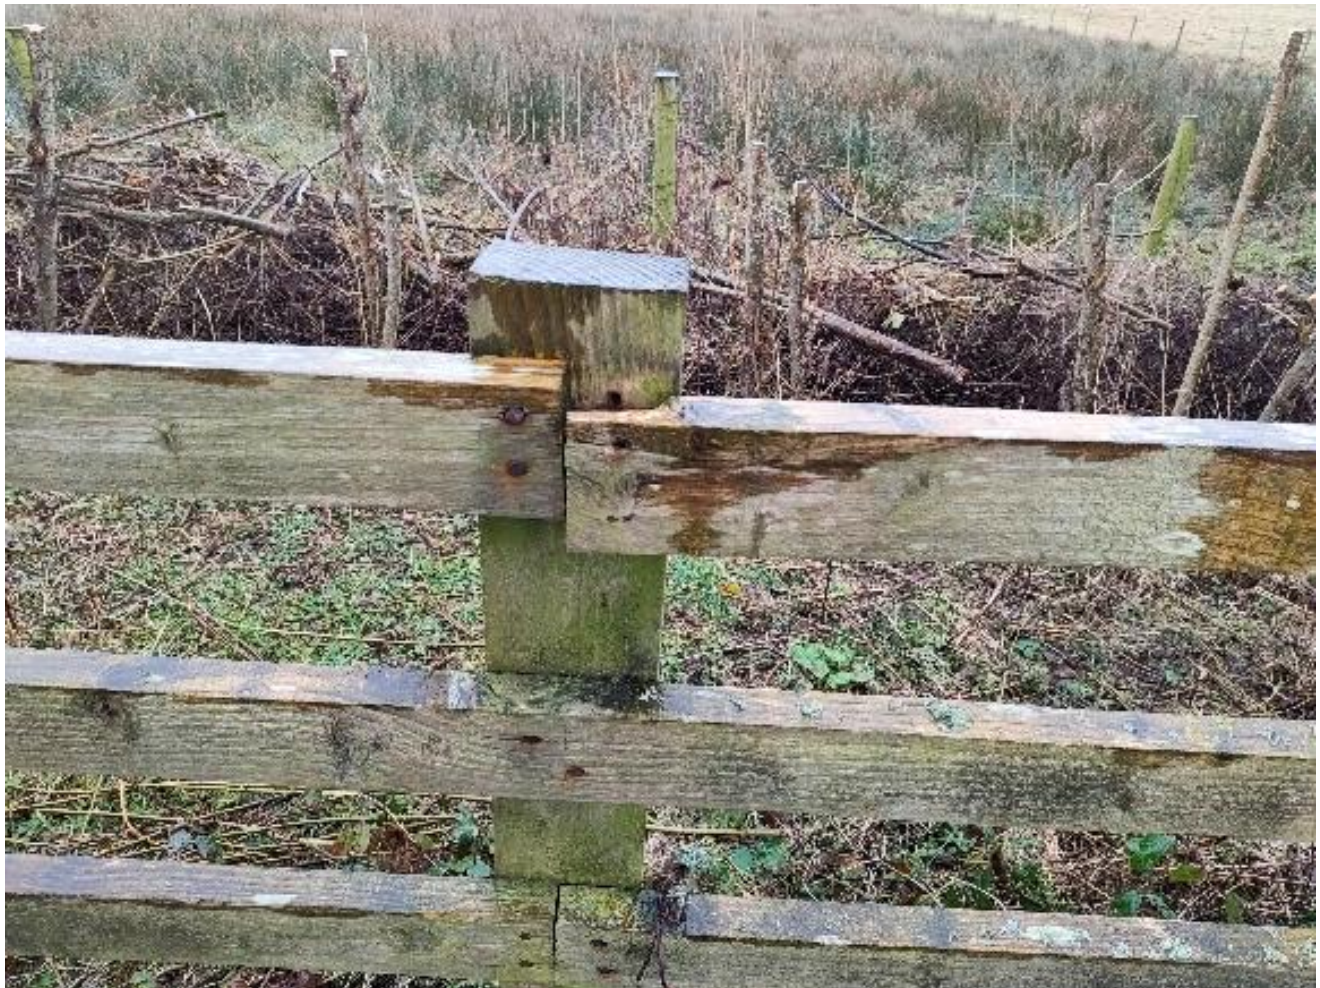
| Item | 12 |

| Location | Boardwalk, Big Meadow side |
| Category | Red |
| Observations | Top rail is rotting at end, displaced from post and placing fence at risk of losing integrity. |

| Recommendations | Repair. |

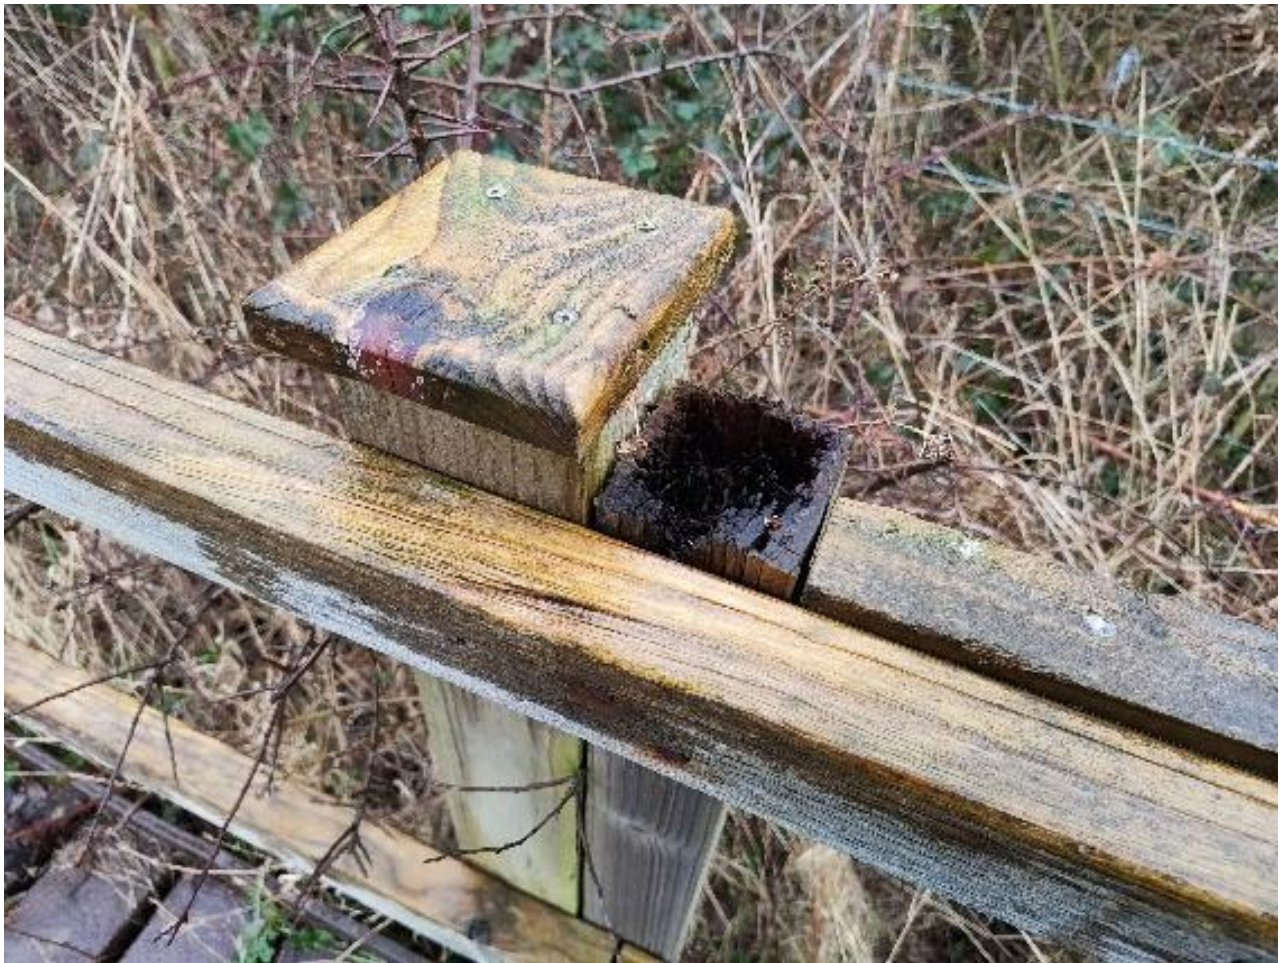
| Item | 13 |

| Location | Boardwalk, Big Meadow side |
| Compliant with best practice? | Yes for original structure, no for repairs. |
| Category | <b>Amber</b> |
| Observations | Post used for repair is rotting and placing fence at risk of losing integrity. |

| Recommendations | Replace and repair. |

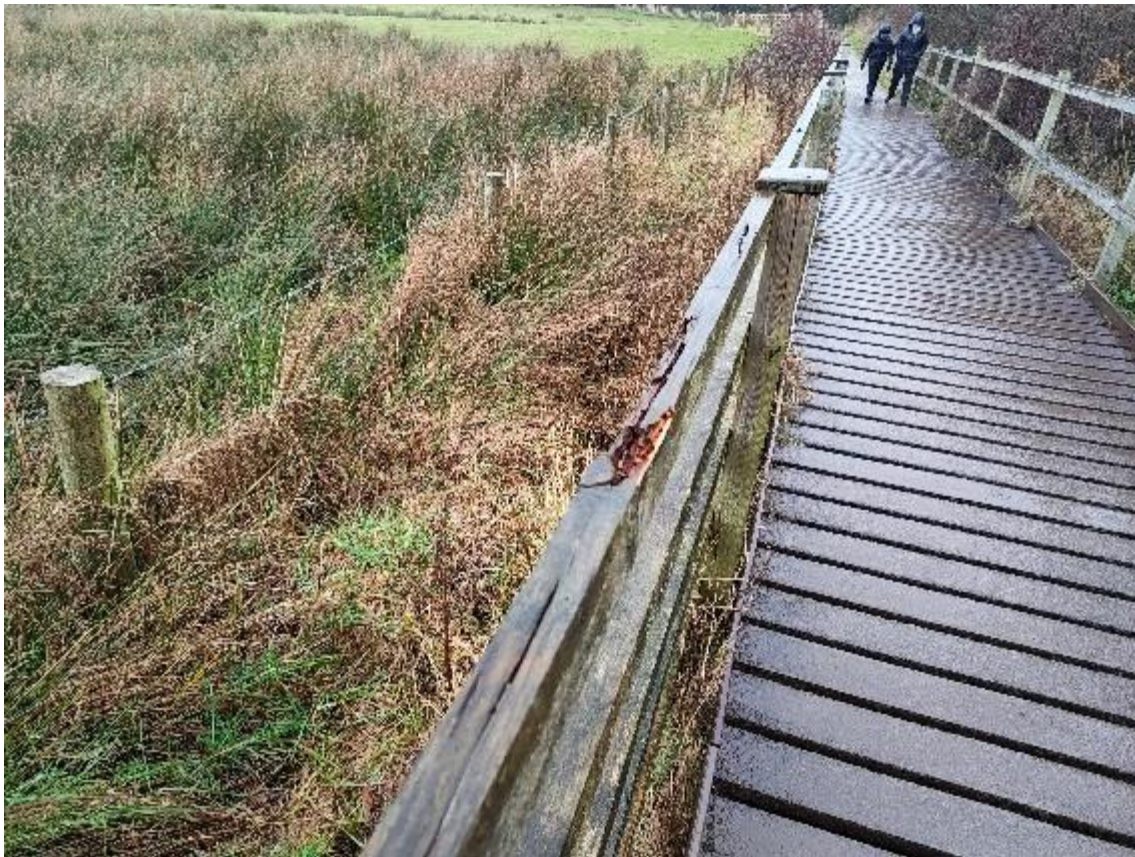
| Item | 14 |

| Location | Boardwalk, Big Meadow side |
| Category | Red |
| Observations | Top rail is rotting, losing integrity and placing fence at risk of losing integrity. |

| Recommendations | Replace and repair. |

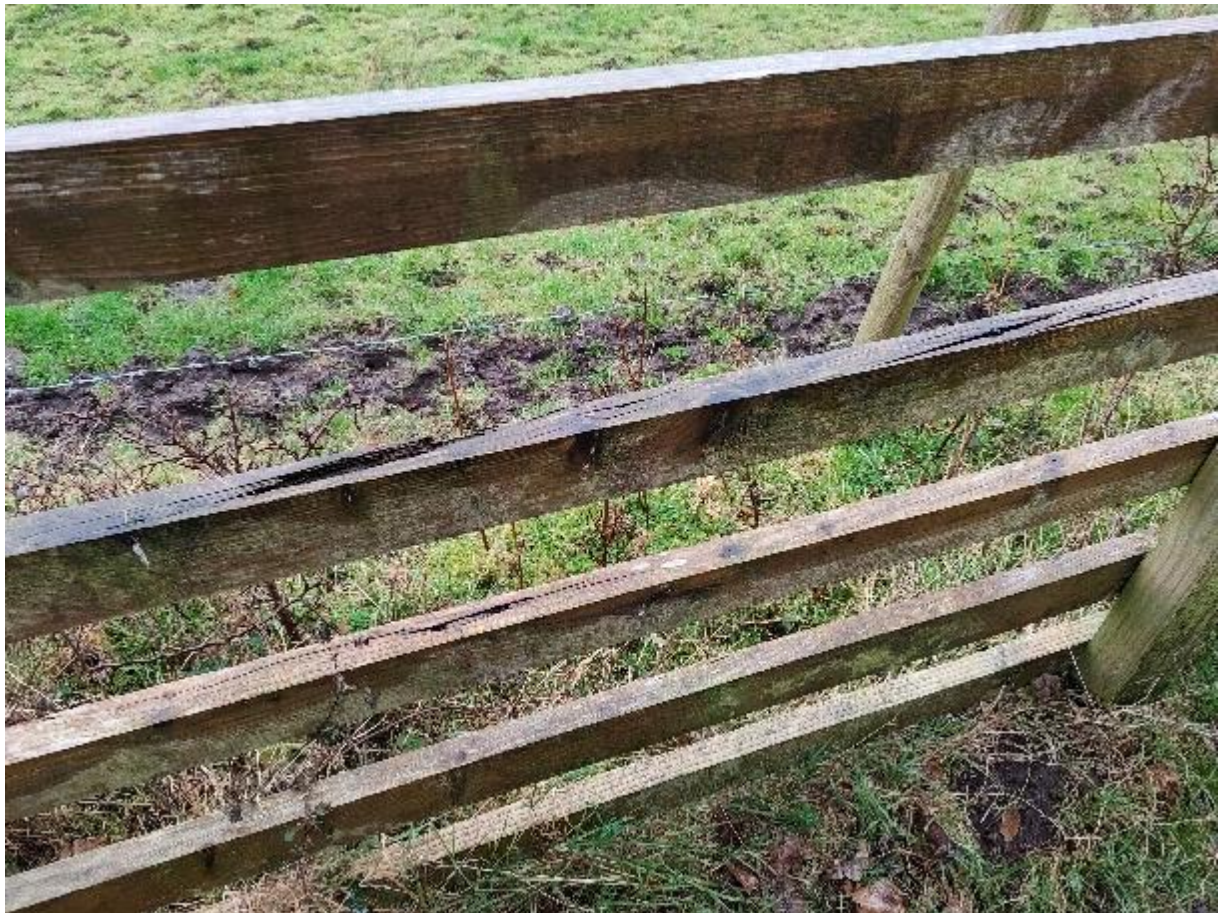
| Item | 15 |

| Location | Boardwalk, Big Meadow side |
| Category | Red |
| Observations | Loose posts and intermediate rails rotting, and placing fence at risk of losing integrity. |

| Recommendations | Replace and repair. |

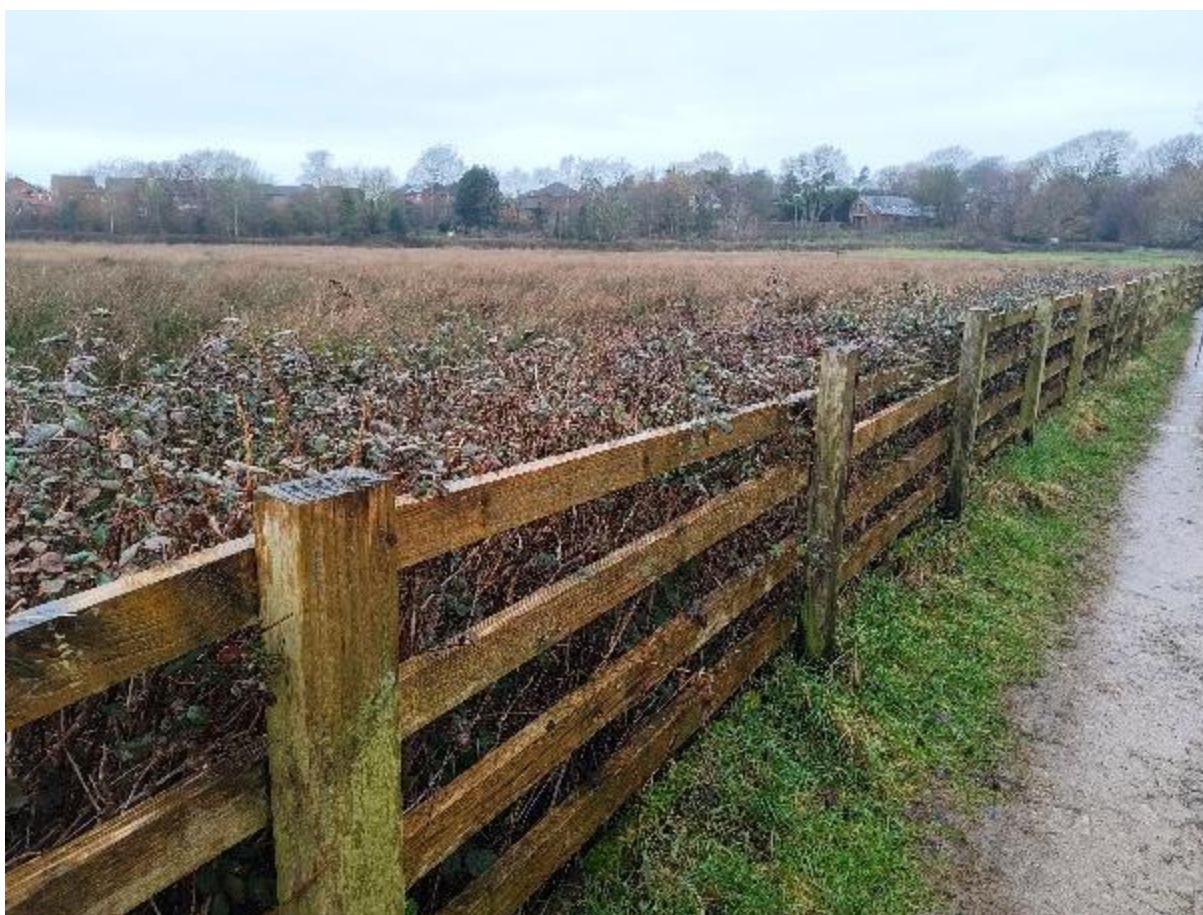
| Item | 16 |

| Location | Big Meadow |
| Category | Red |
| Observations | Rail displaced, rotting at end. Post is loose. |

| Recommendations | Investigate cause of loose post, repair. |

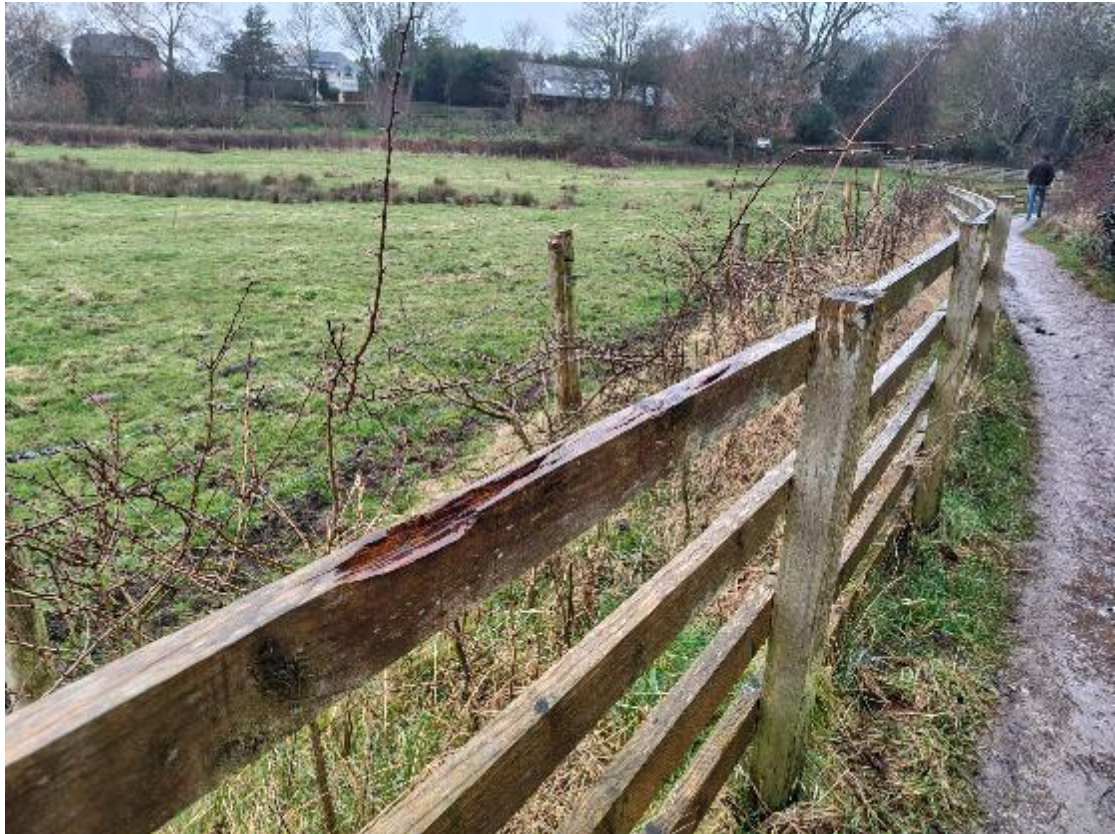
| Item | 17 |

| Location | Big Meadow |
| Category | <b>Red</b> |
| Observations | Top rail is rotting, losing integrity, and placing fence at risk of losing integrity. |

| Recommendations | Replace and repair. |
