## Summary – Fences survey, January-February 2026

This report describes the fence survey carried out in January and February 2026. It describes the types of fences on the nature reserve, explains the assessment criteria for the survey, identifies the gates and fences in need of repair, and makes further recommendations.

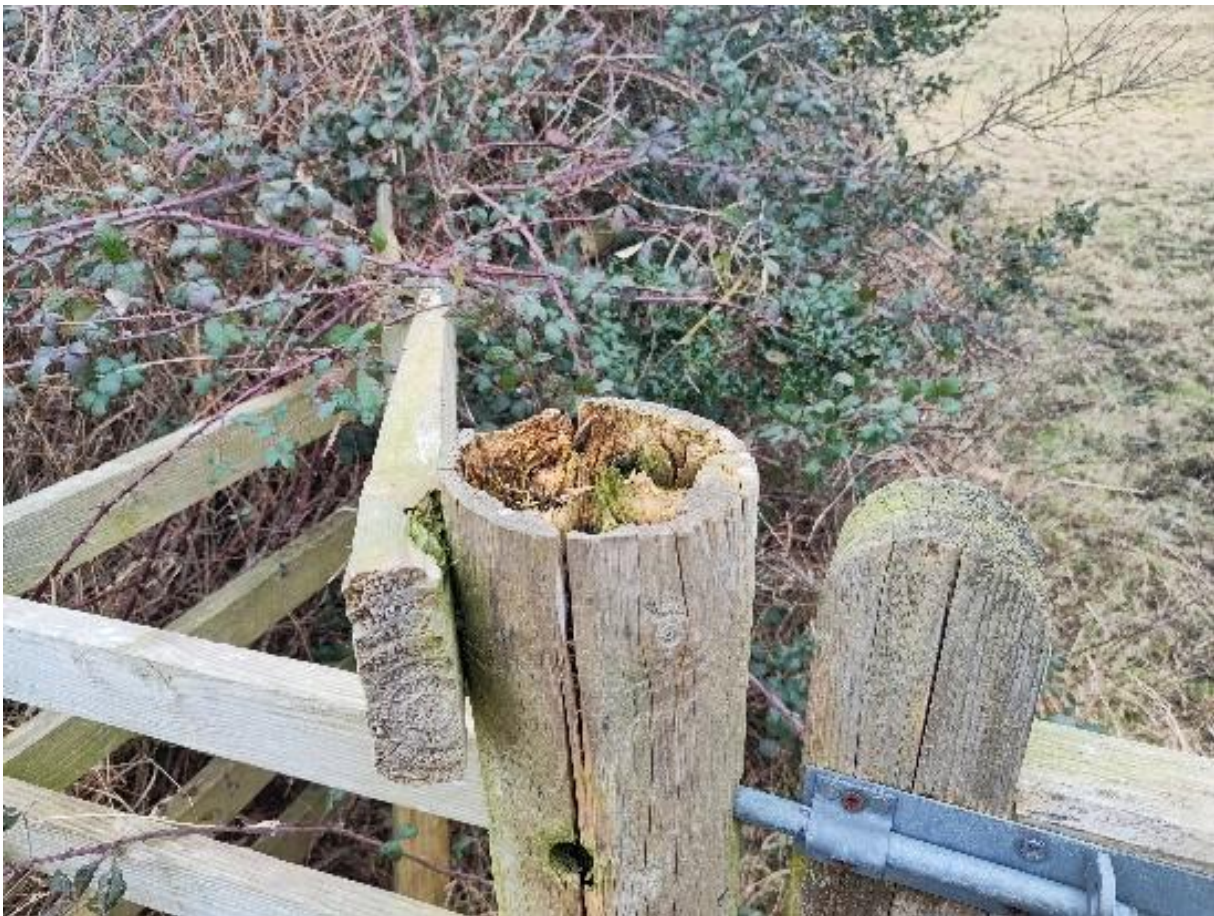
| Item | 18 |

| Location | Gate to LGGS field from Fauna Path |
| Category | Amber |
| Observations | Top of gate post is rotting and losing integrity. |

| Recommendations | Trim top of post, replace top, repair. |

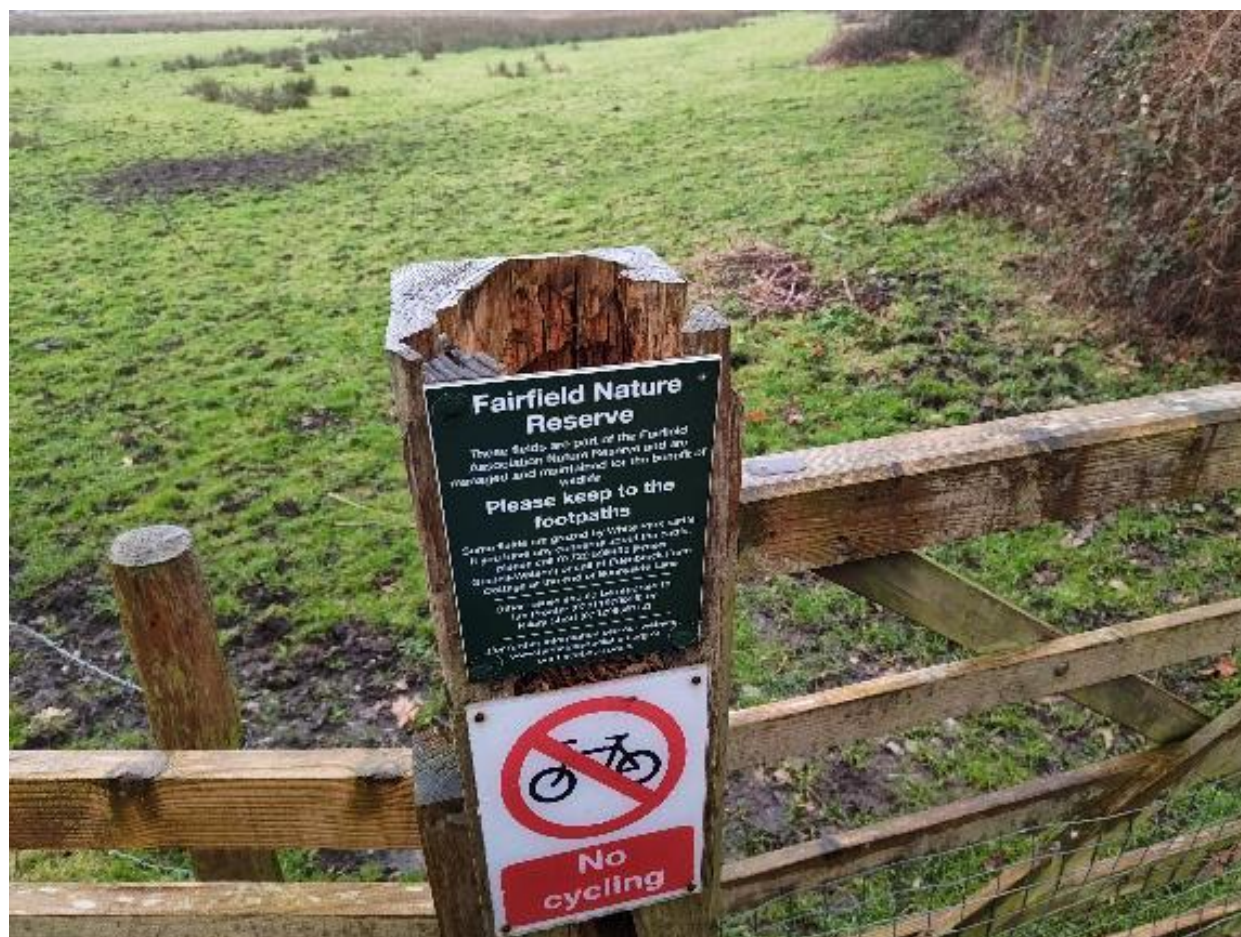
| Item | 19 |

| Location | Big Meadow, Gate near orchard |
| Category | <b>Red</b> |
| Observations | Top of gate post is rotting and losing integrity. |

| Recommendations | Replace and repair. |

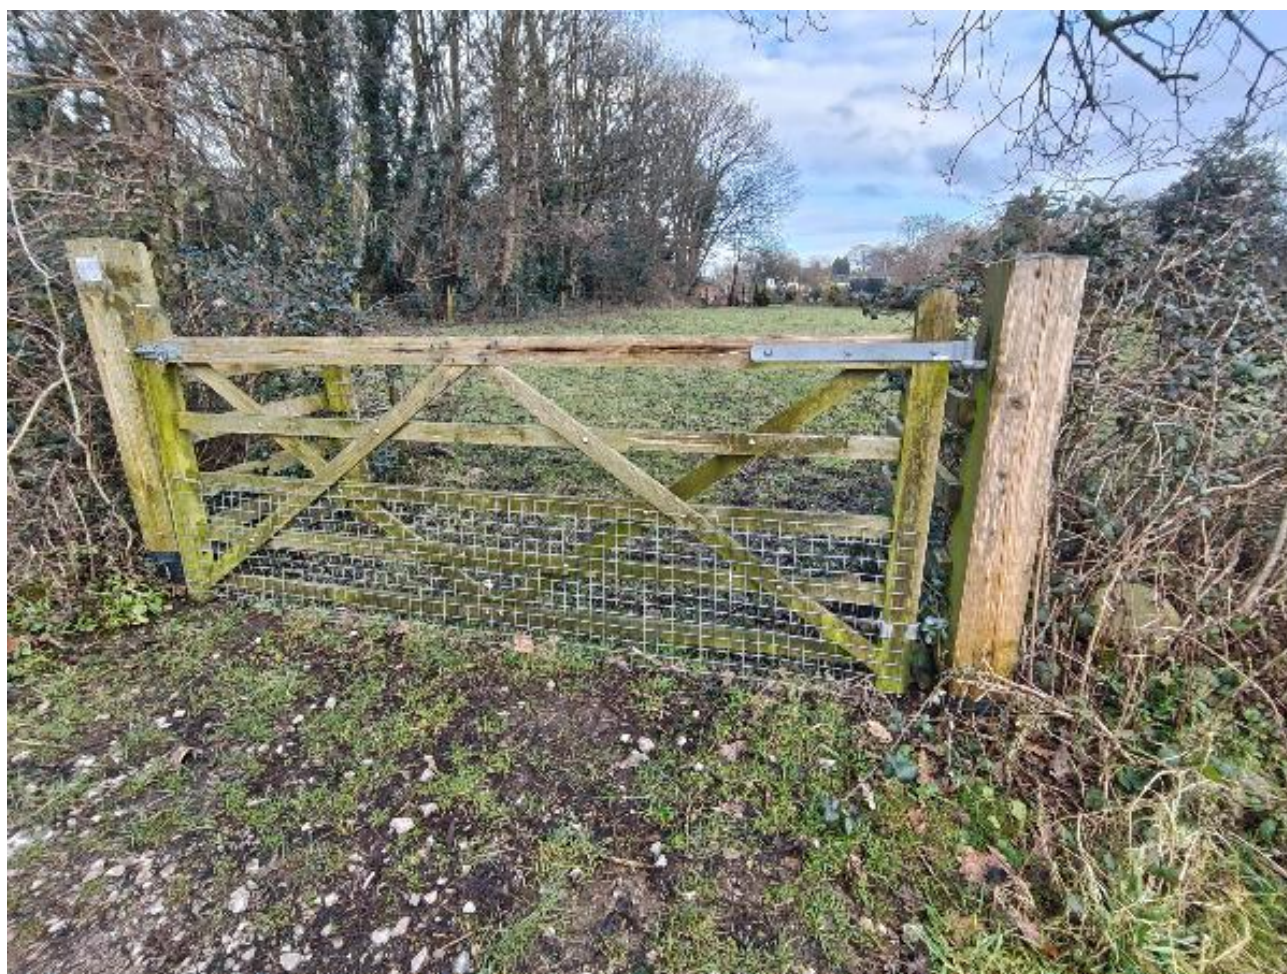
| Item | 20 |

| Location | Gate at Edenbreck Paddock |
| Category | <b>Amber</b> |
| Observations | Top rail is rotting and starting to lose integrity. |

| Recommendations | Monitor and schedule repair. |

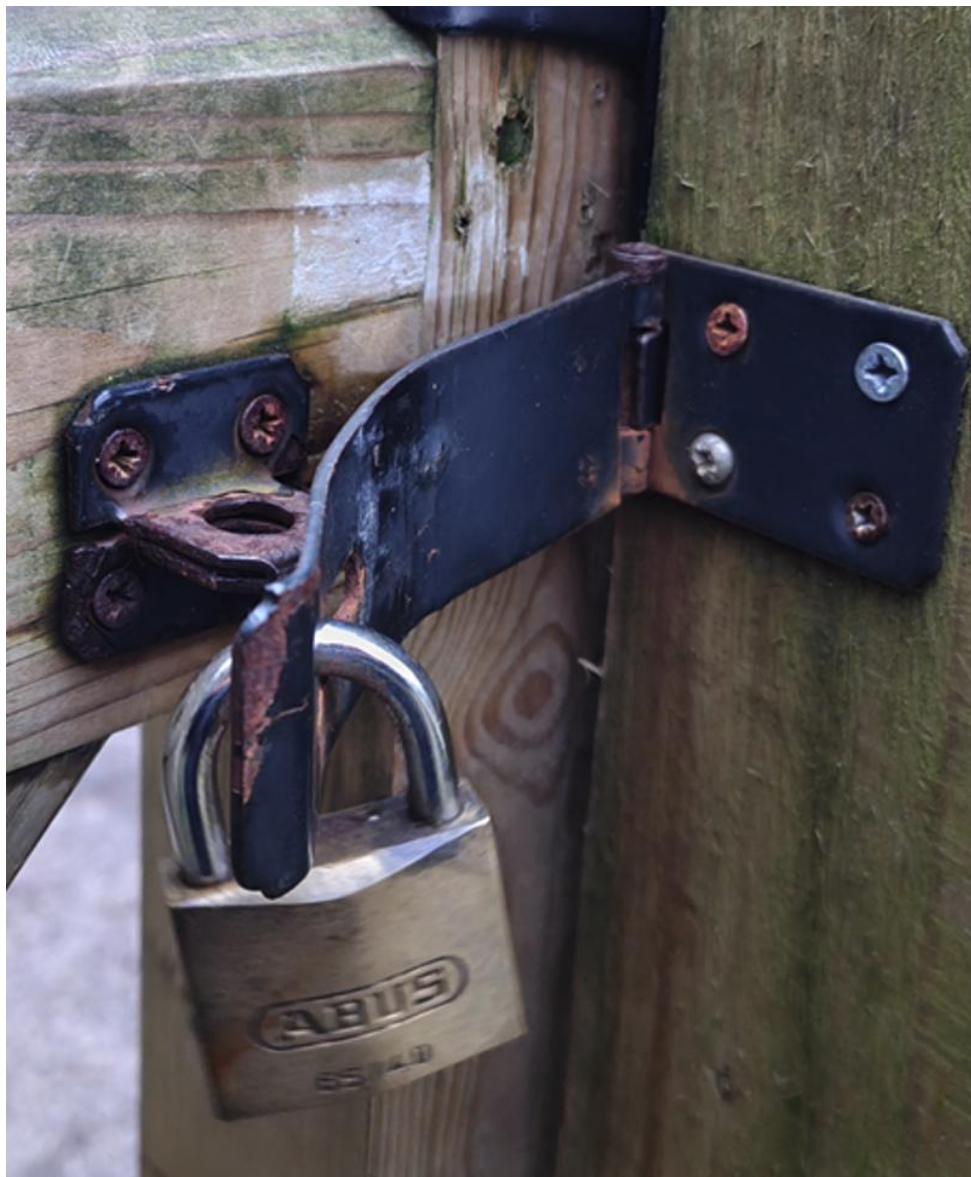
| Item | 21 |

| Location | All padlocks and hasps |
| Category | Amber |
| Observations | Many padlocks are now difficult to open, whilst some hasps are corroded. |

| Recommendations | Inspect all padlocks and oil them. Any padlocks that do not respond to oiling should be replaced. Replace severely corroded hasps. |

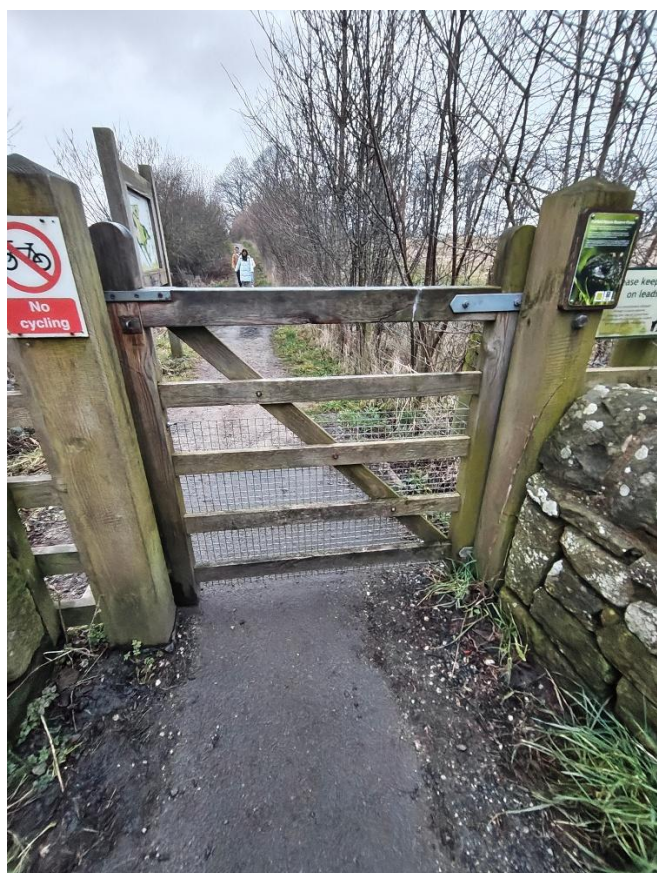
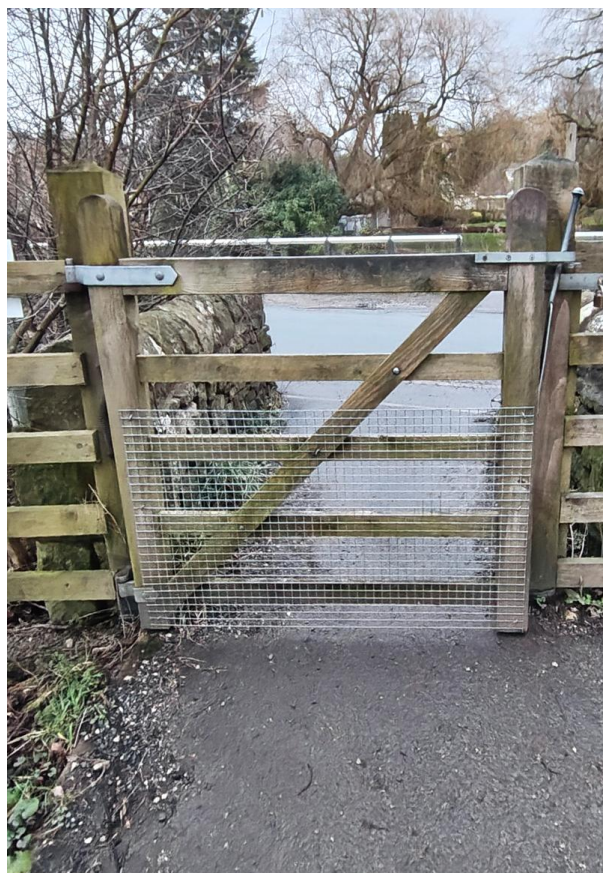
| Item | 22 |

| Location | Aldcliffe Road, gate to Pony Wood |
| Category | <b>Amber</b> |
| Observations | There have been suggestions to improve access via this gate, which can be difficult to open. Currently the gate can only open in one direction, as the gate is wider than the posts; changing this would require a narrower gate. |

| Recommendations | Investigate solutions. |

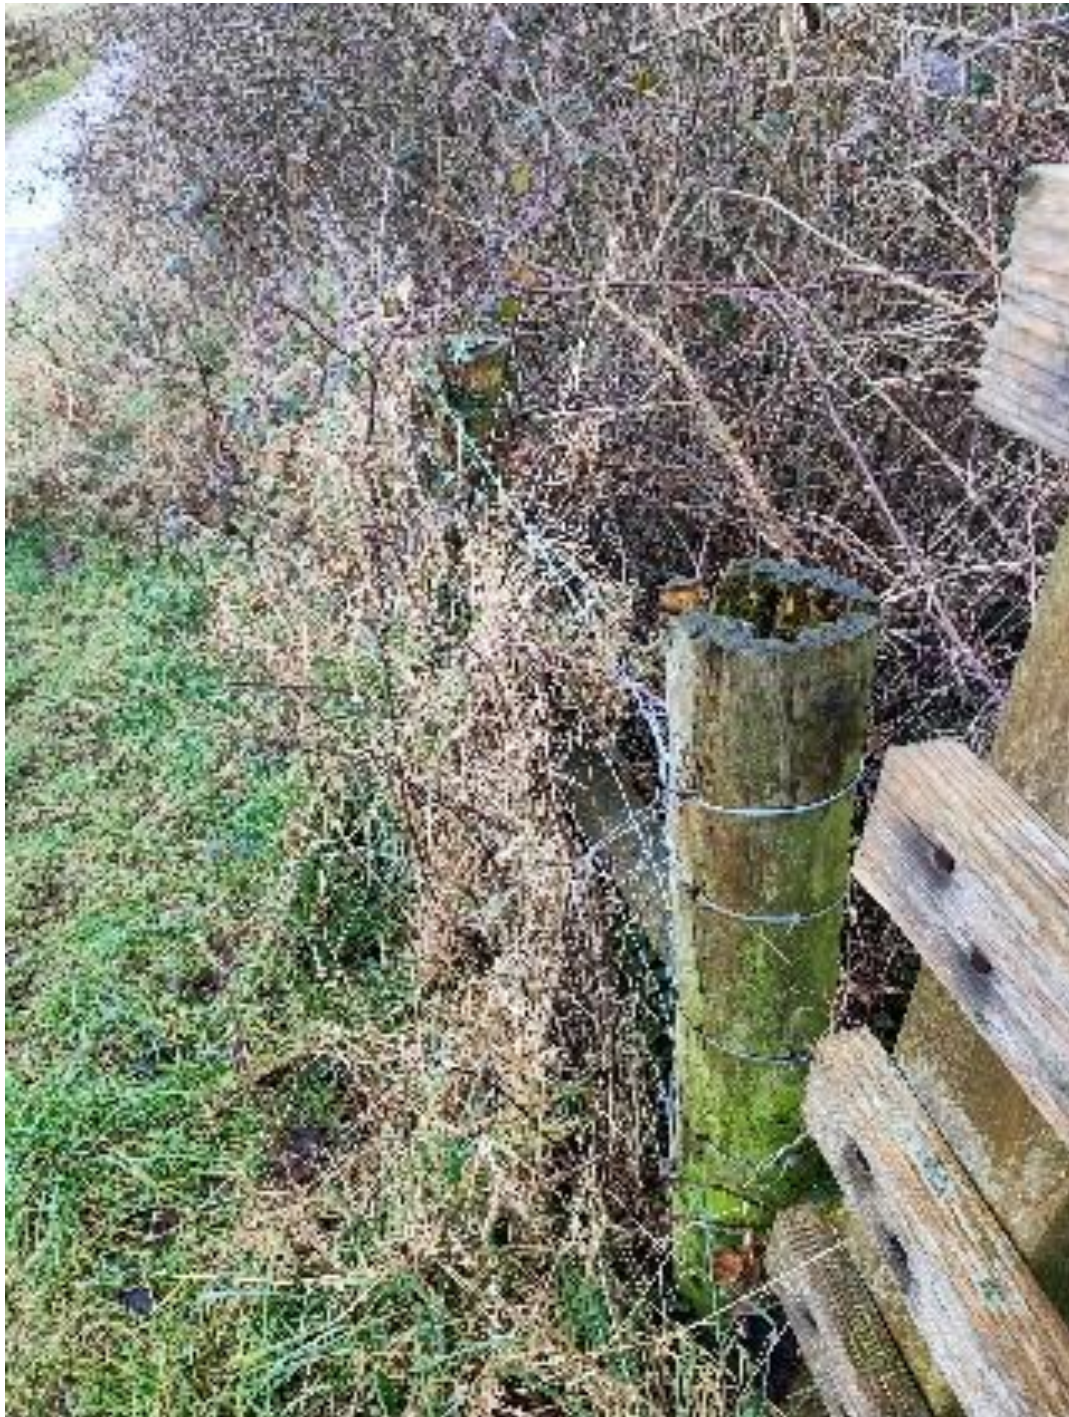
| Item | 24 |

| Location | Carr House Meadow |
| Category | <b>Amber</b> |
| Observations | Strainer post is rotting and starting to lose integrity. |

| Recommendations | Schedule repair; trim top and replace with new wood. |

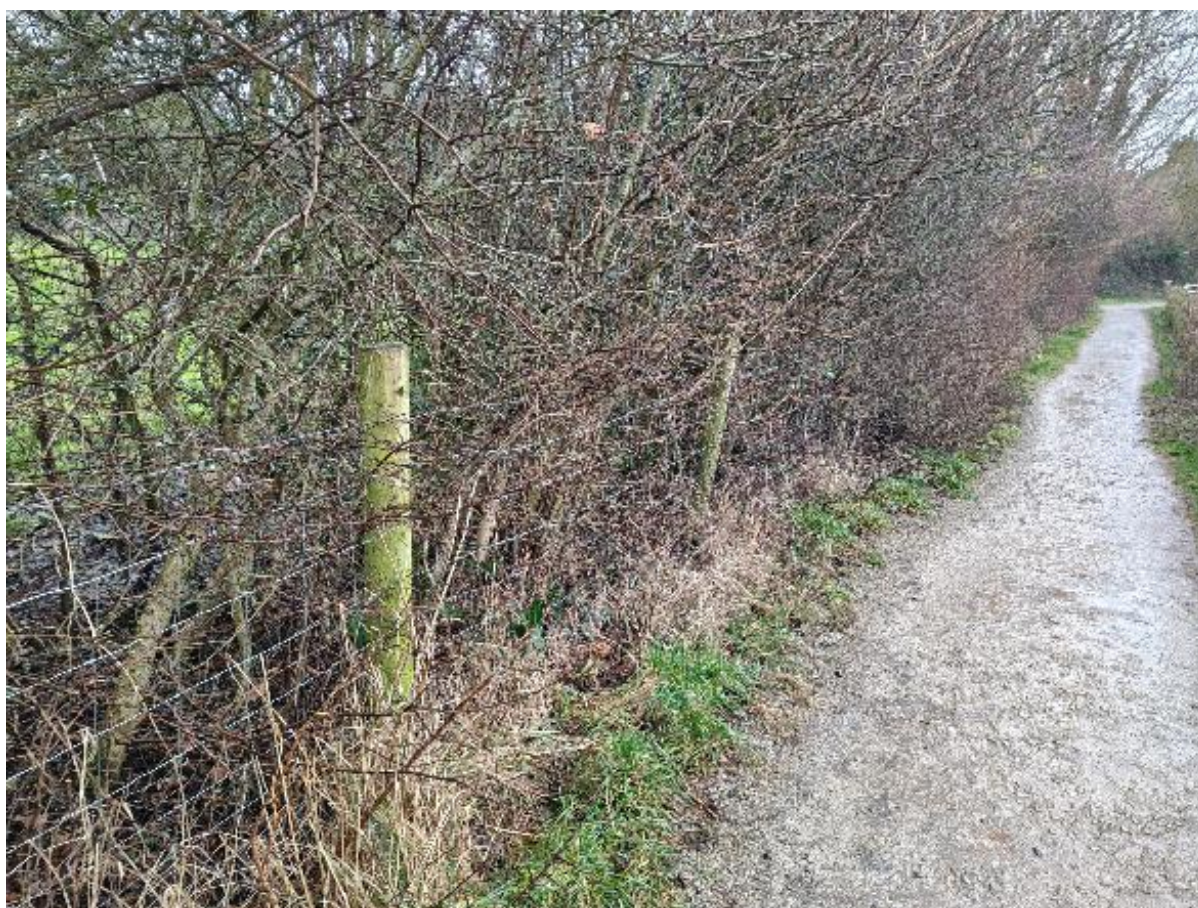
| Item | 25 |

| Location | Carr House Meadow from footpath |
| Category | <b>Amber</b> |
| Observations | Loose posts, losing tension. |

| Recommendations | Investigate and schedule remedy. |

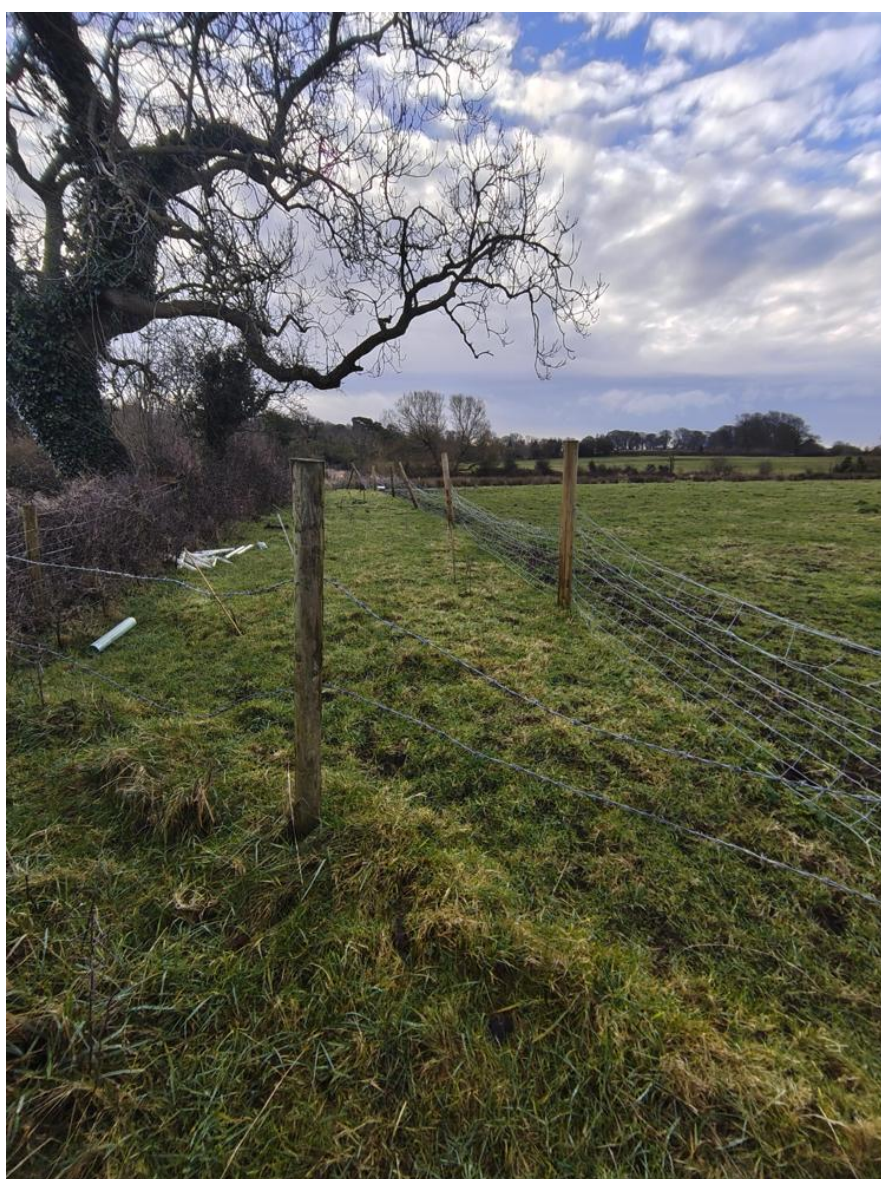
| Item | 26 |

| Location | Big Meadow, small area of fencing near to boundary with Hay Meadow. |
| Compliant with best practice? | No – absence of strainer posts and lack of tension. |
| Category | <b>Amber</b> |
| Observations | The fence is not a proper stock-proof enclosure and has been pushed and trampled by cattle. |

| Recommendations | Replace with a stock-proof fence.<br><b>NOTE:</b> The fence has since been repaired, with barbed wire added. However, this fence still does not comply with the applicable British Standard and similar requirements. |

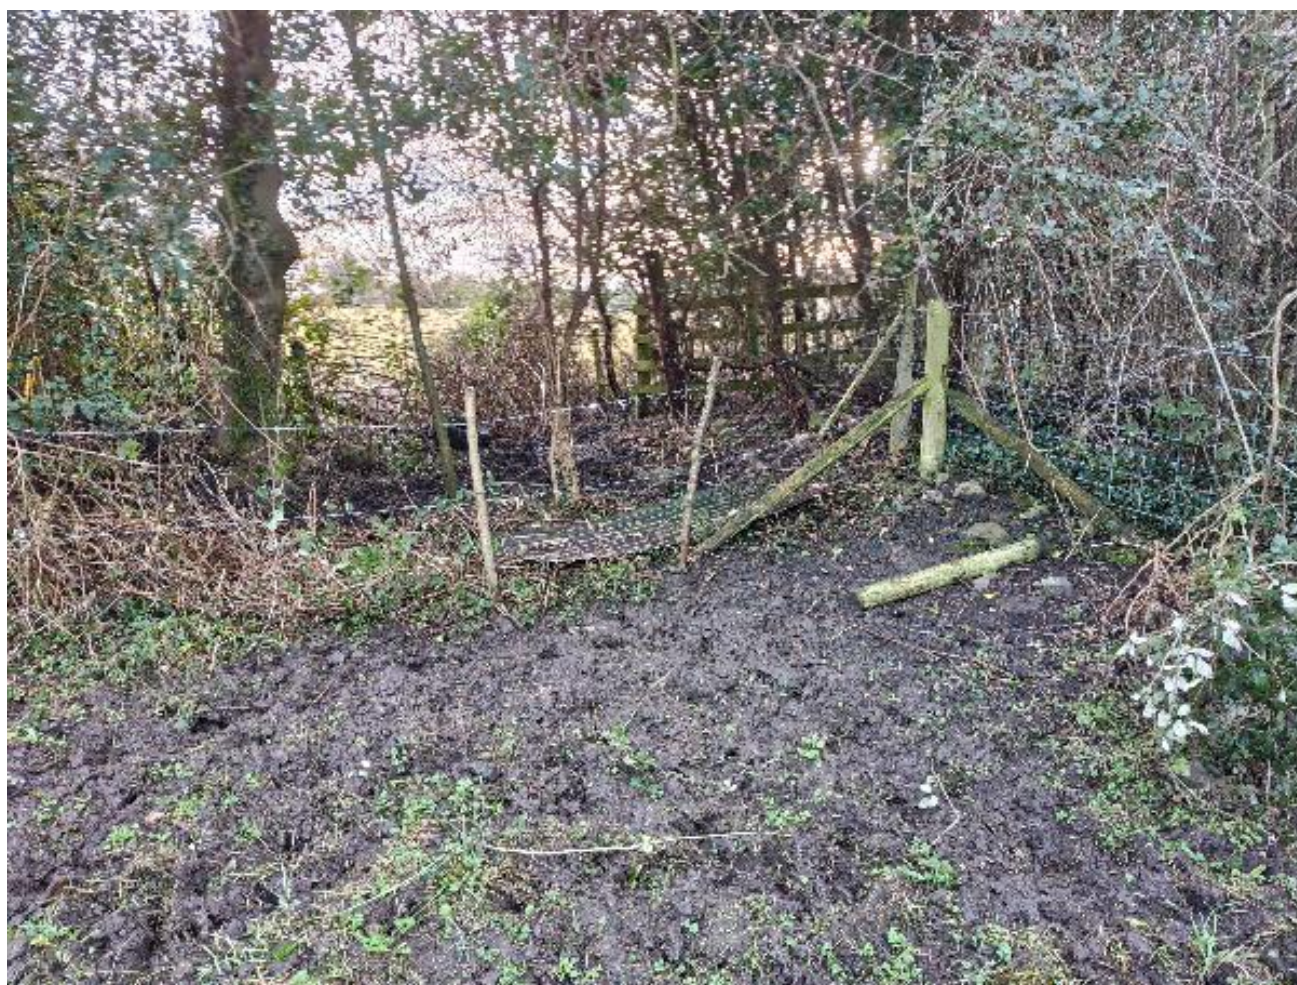
| Item | 27 |

| Location | Edenbreck Paddock |
| Category | <b>Red</b> |
| Observations | The fence appears to have been originally stock proof, but the wet ground and make-shift repairs mean that the fence has little tension, insecure posts and is no longer stock proof. |

| Recommendations | Replace or investigate alternatives, e.g. partial fencing to secure boundary with LGGS field. |

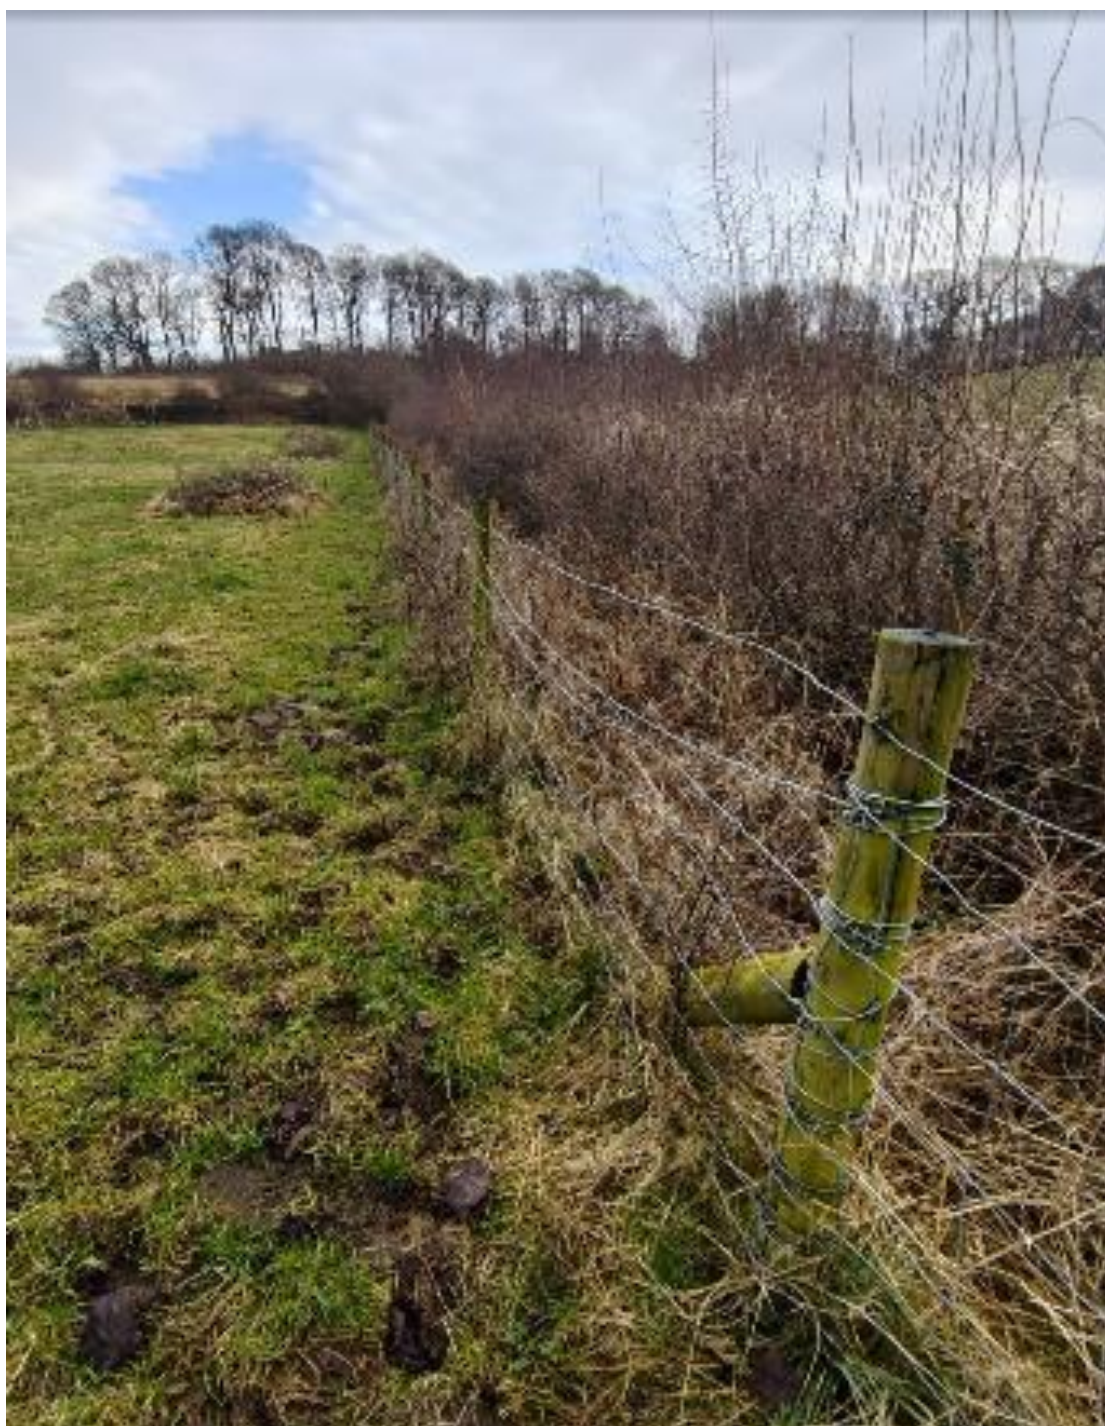
| Item | 28 |

| Location | West Field |
| Category | Amber |
| Observations | The fence has lost tension, and is losing structural integrity. |

| Recommendations | Schedule repair. |

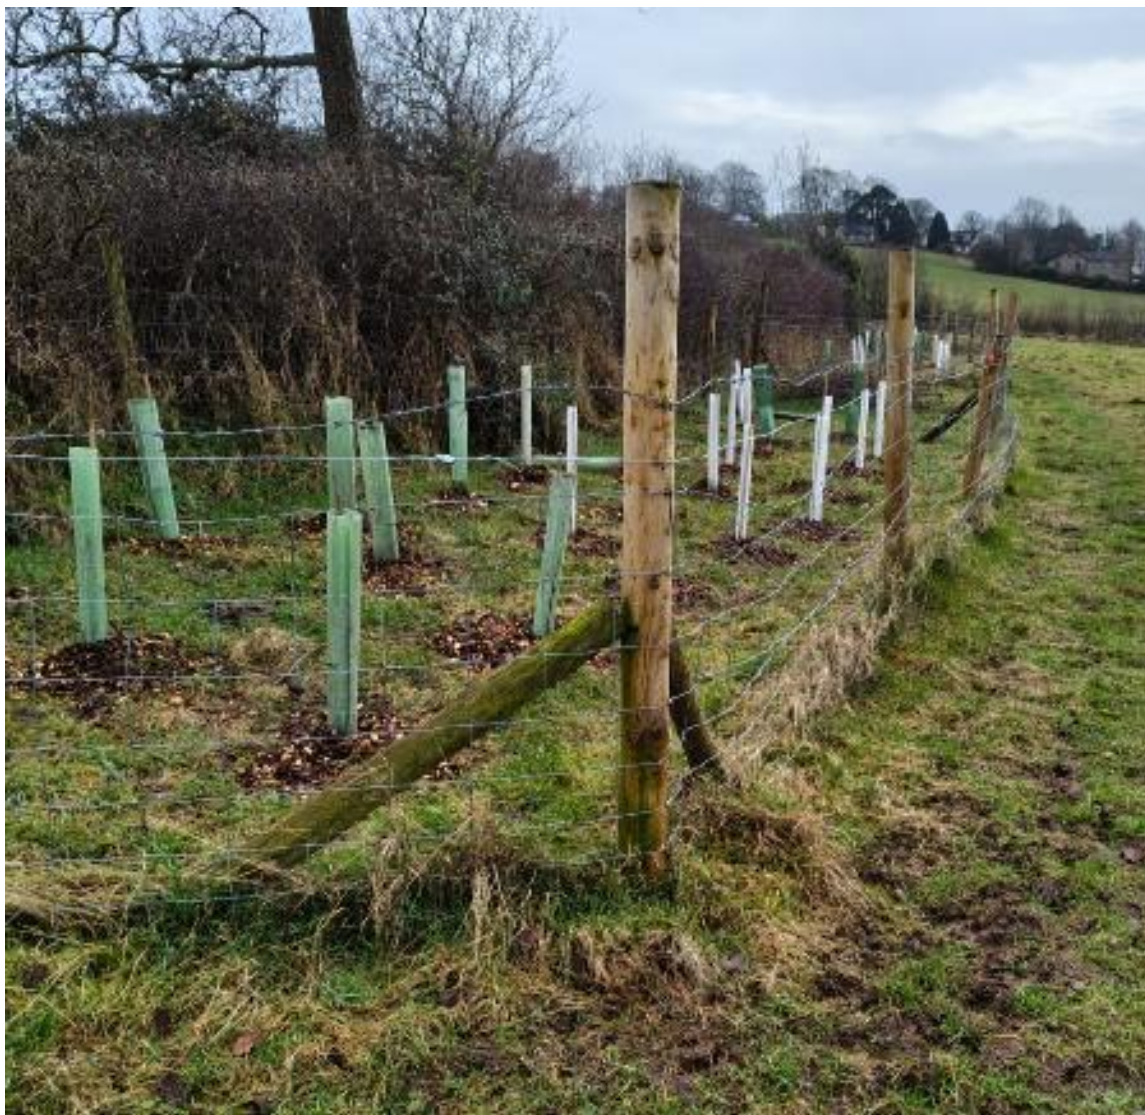
| Item | 29 |

| Location | West Field |
| Compliant with best practice? | Partial |
| Category | <b>Amber</b> |
| Observations | The fences do not have strainer posts and therefore it has not been possible to tension them sufficiently. |

| Recommendations | Monitor when cattle are in the field – repair if the fences lose integrity. Replace corner posts with larger, deeper conventional straining posts and tension the wires firmly using a monkey strainer. |

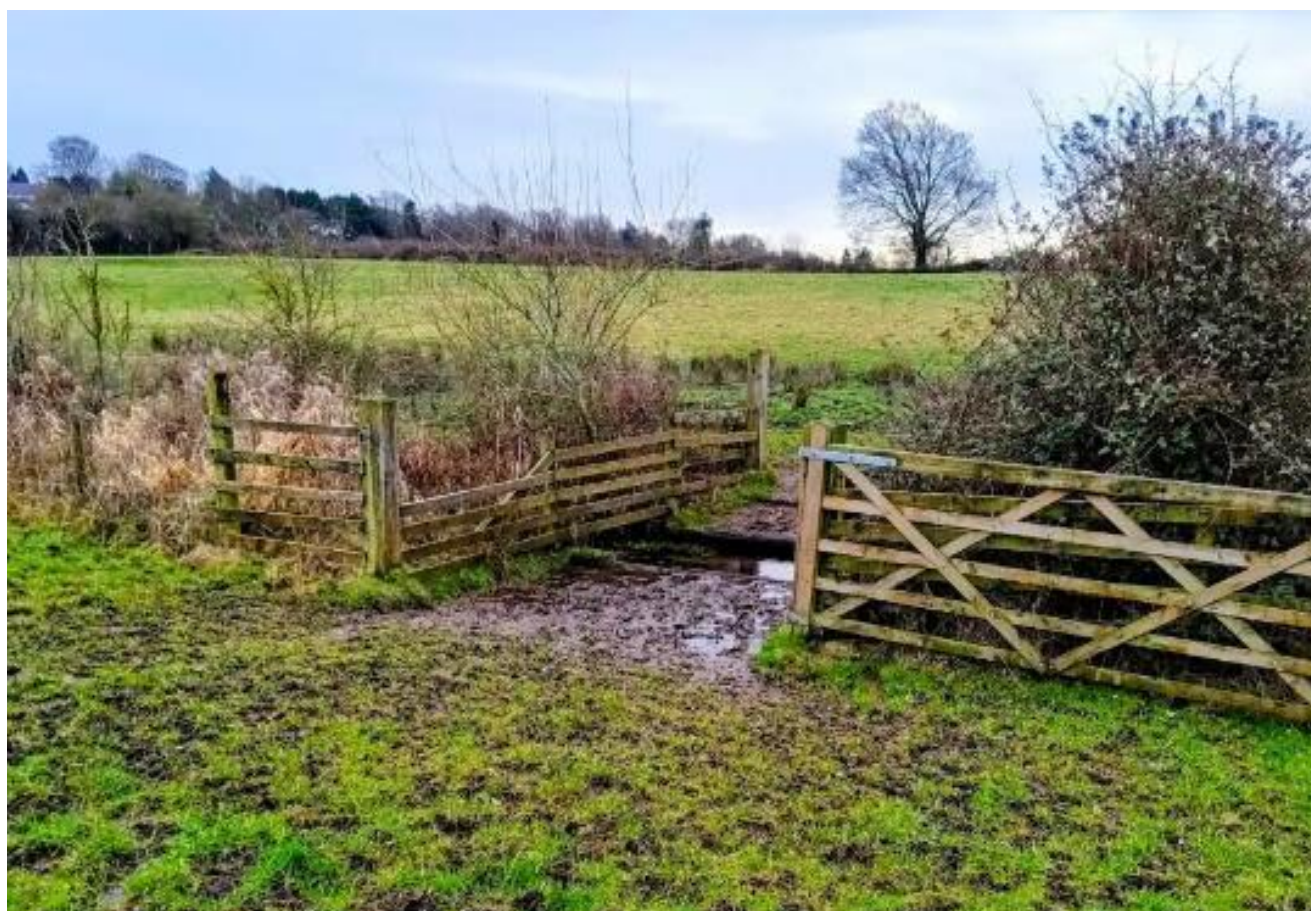
| Item | 30 |

| Location | Gated area, Big Meadow to Lower Sowerholme |
| Category | <b>Amber</b> |
| Observations | Some rails are rotting and are ajar. |

| Recommendations | Repair and replace rails where needed. |

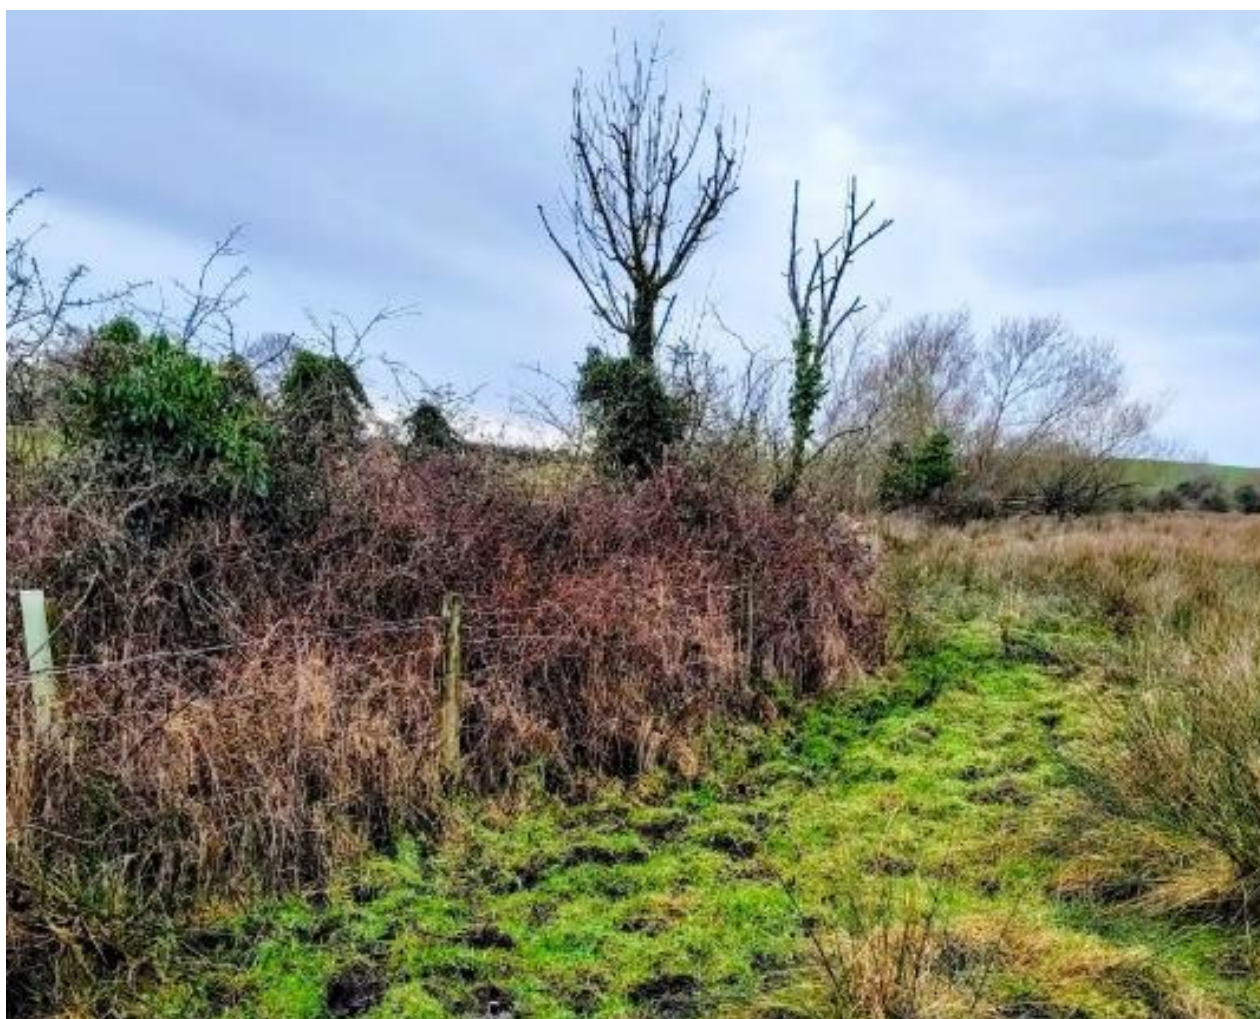
| Item | 31 |

| Location | East section of Big Meadow |
| Category | Amber |
| Observations | The fence is aged and degrading. |

| Recommendations | Monitor cattle movements; schedule replacements. |

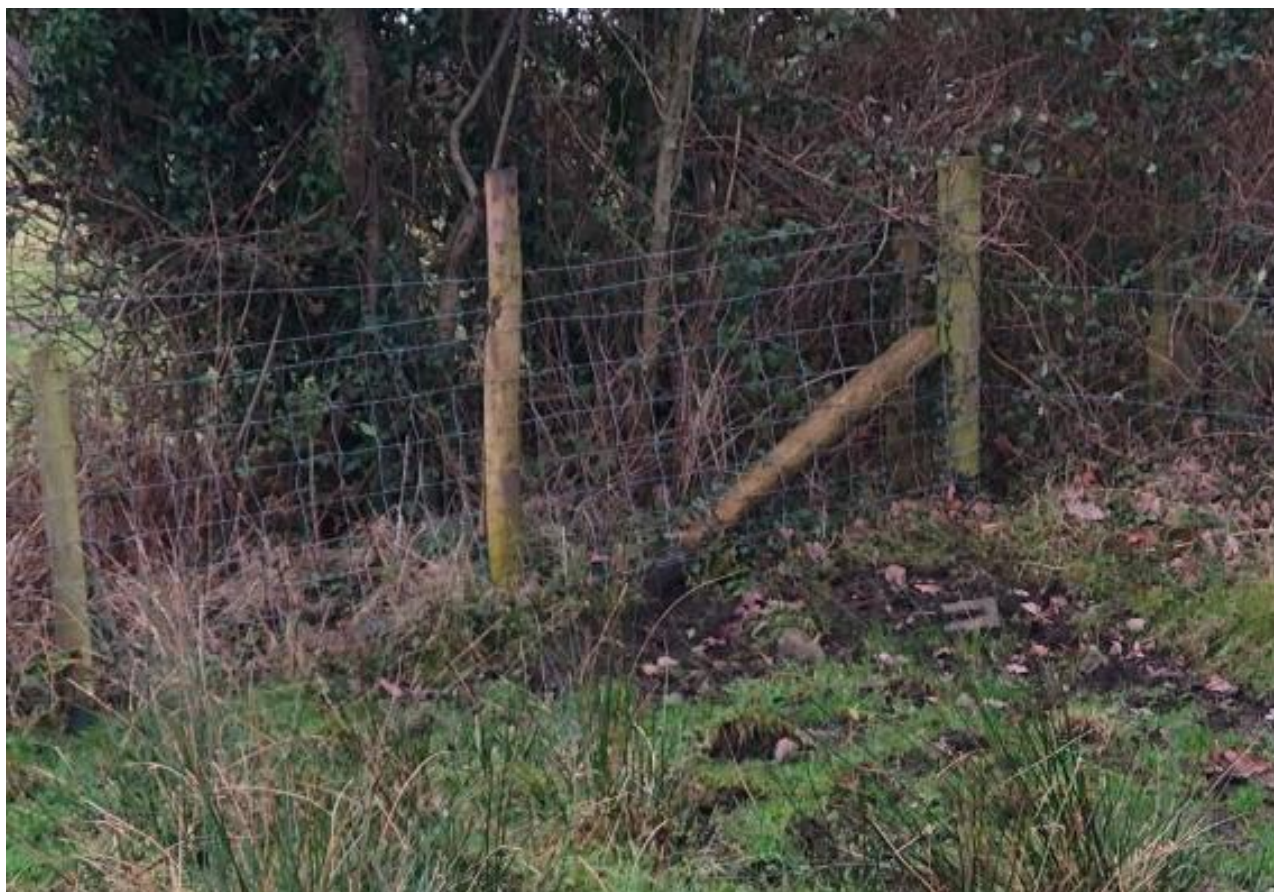
| Item | 32 |

| Location | Big Meadow to Lower Sowerholme fence |
| RAYG status | <b>Amber</b> |
| Observations | The strainer post is starting to rot and the fence has lost some tension. |

| Recommendations | Monitor and schedule repair. |

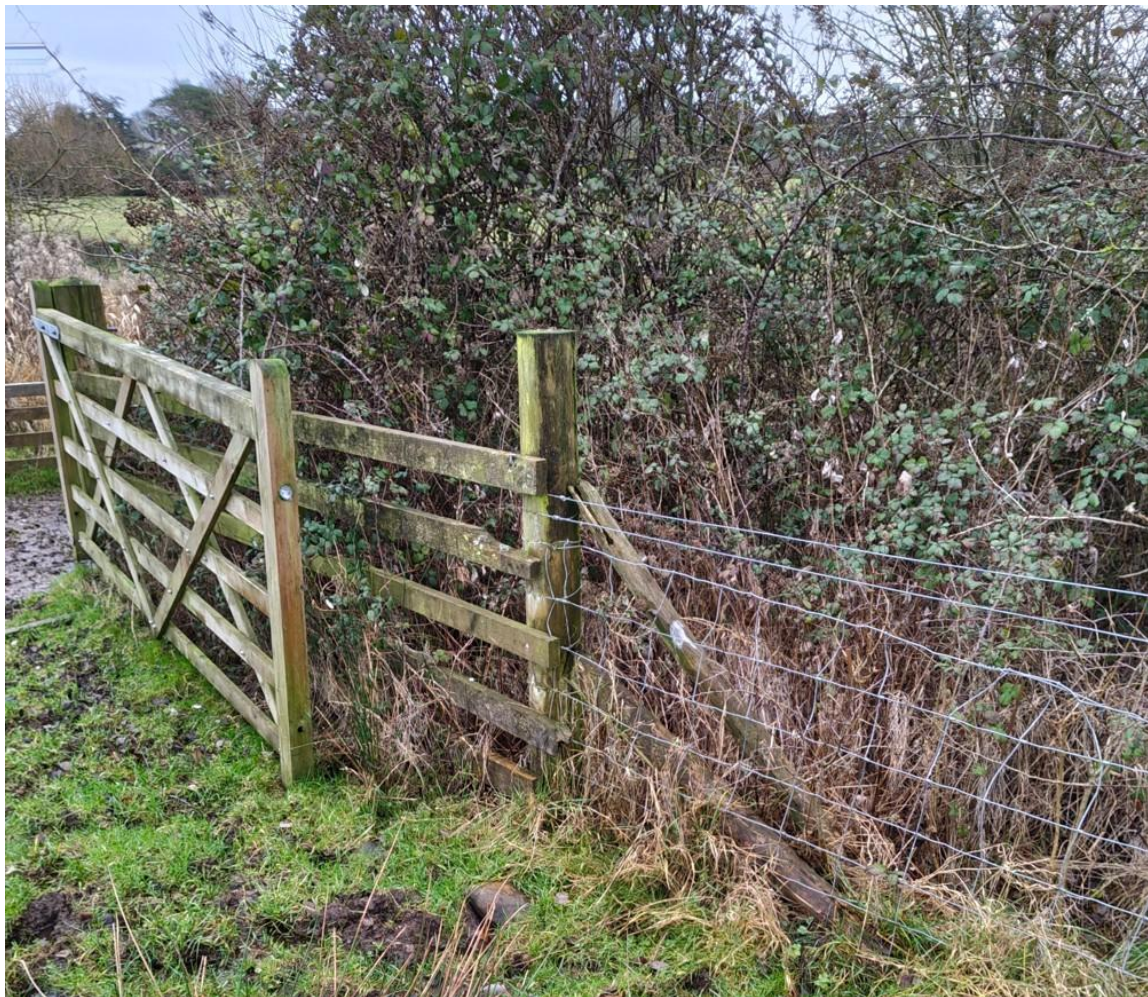
| Item | 33 |

| Location | Hay Meadow to Big Meadow |
| RAYG status | <b>Amber</b> |
| Observations | The strainer post is starting to rot and the fence has lost some tension. One of the rails on the section of post-and-rail fencing is rotting. |

| Recommendations | Monitor and schedule repair. |
