### **Re : Buildings on the Aldcliffe Triangle**

This is to confirm that on the 24<sup>th</sup> February 2013, I inspected buildings located in the Aldcliffe Triangle in Lancaster with a view to determining their likely use by, and importance to, bat species. The inspection was requested as the area is considered to have a high likelihood of bat species being present, due to the location which is adjacent to the Lancaster Canal.

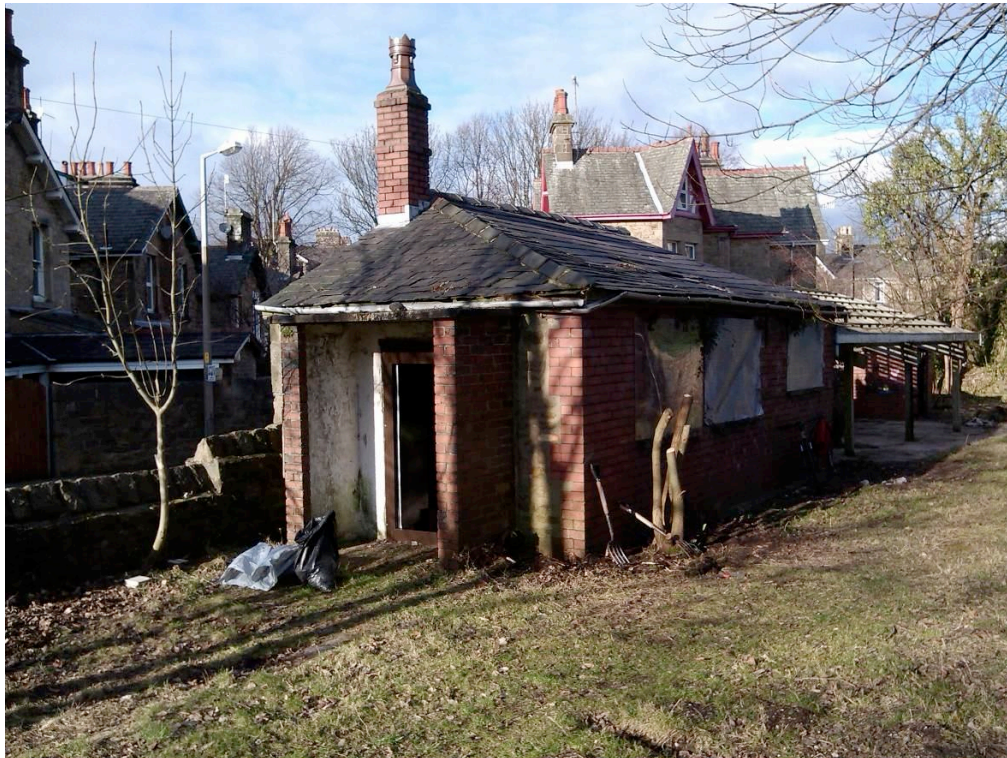
The buildings are small and constructed from some stone and some red brick. The roofs are of traditional small slates on timber frames. Building A has a brick chimney and the roof slates are underlined with plasterboard. Building B has a pent roof and the slates are underlined with roofing felt. Building A is to be renovated and building B is to be demolished.

The interior of Building A was searched to look for signs of bats such as bat droppings but none were found. The roof slates are underlined with plaster board which is still intact in places. It is therefore possible for bats to roost under slates without any evidence being seen inside the building. An external inspection of the walls, windows, sills and doors was made to look for bat droppings deposited as bats fly out from their roost sites at night but none were found.

3. Remove existing slates and other roof materials by hand and taking care not to twist or bang. Check the underside of ridge tiles. Keep a careful watch for bats during this operation.

It is likely that the site could be enhanced for bats by considering their needs before and during the renovation programme for Building A. Simple and inexpensive measures include :

- ⇒ The provision of bat boxes which could be located on the chimney of the renovated building
- ⇒ The provision of “bat” slates near to the apex of the renovated building, as per the plan at **Appendix A**
- ⇒ The provision of “ridge tile” roosts in the renovated building, as per the plan at **Appendix B**

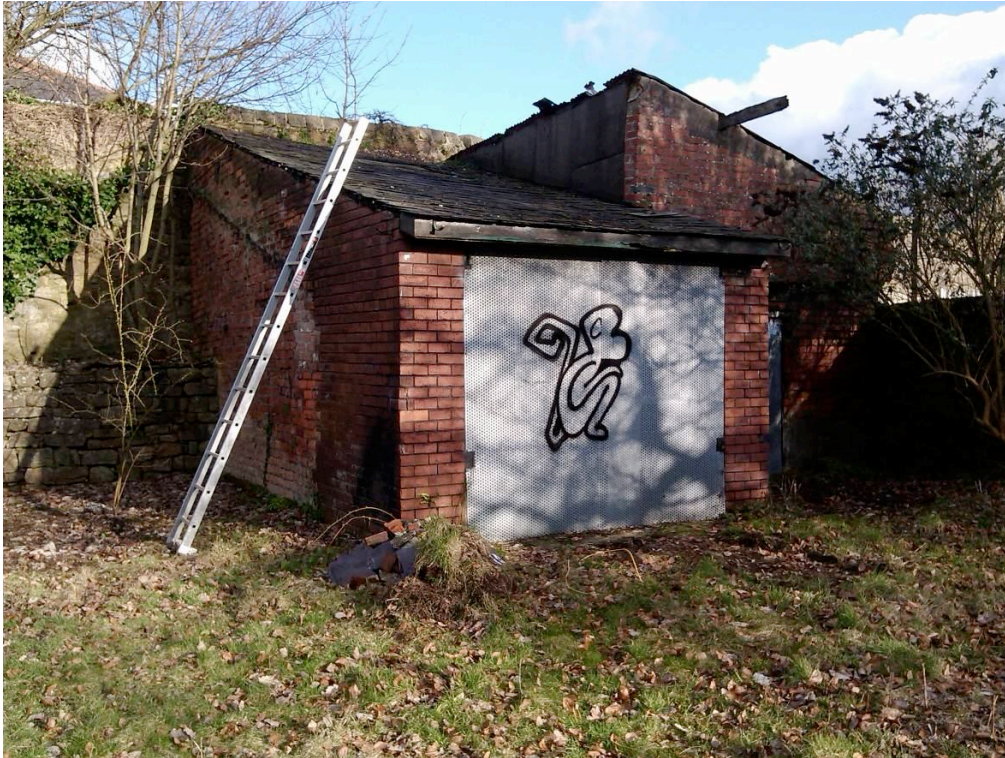
The exterior of Building B was inspected to look for potential roost sites. There is potential access along the roof verge of this building and it is possible that bats could enter to roost between roof slates and underfelt. The roof verge was closely inspected from the top of a ladder and the gap was found to be relatively open, probably not providing the stable and secure roost sites that bats seek except on an occasional or temporary basis. There were no bat droppings, grease or scratch marks which would be indicative of regular or longstanding use by bats.
