Canal &
River Trust

RAPID HERITAGE ASSESSMENT

Waterway: Lancaster Canal

Structure: Aldcliffe Road

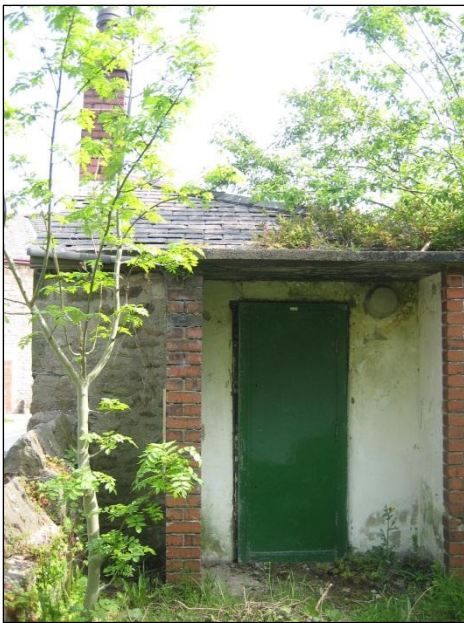
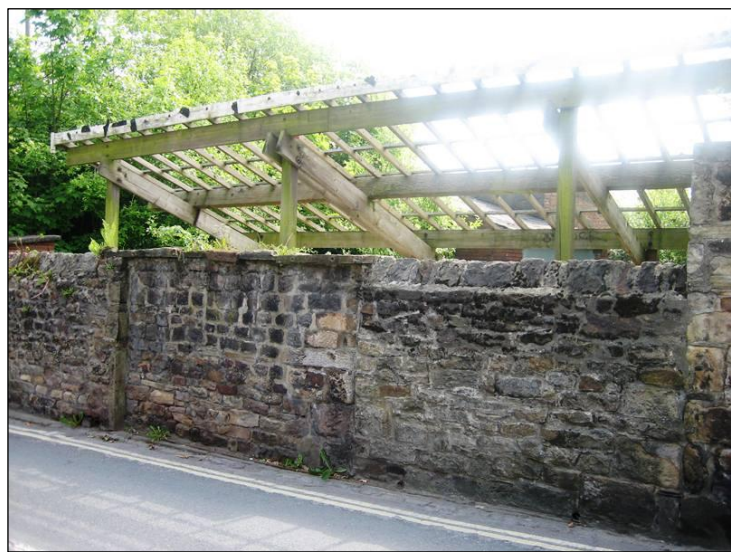
Former Canal Office: Brick porch front elevation Timber framed car-port rear elevation

The former canal office is located on the north west of the site and as part of the enhancement plans it is to be refurbished. The exact date of its original construction is unknown at this point; it does however appear to have been built according to the historic Ordnance Survey (OS) maps between 1848 and 1893. It is a standalone which has undergone a number of alterations and repairs. Its northern wall is included in the boundary wall which separates the site from Aldcliffe Road. Evidence suggests that it was originally built in stone with later repairs and alterations carried out in brick. The chimney is constructed of brick which on inspection looks to be a later repair. Attached to the building on the rear elevation is a timber framed car-port which was thought to be erected by the previous tenant approximately in the 1990's. Evidence of its original use as well as its aesthetic qualities makes this building of some historical significance as part of the wider group of canal related buildings and structures.

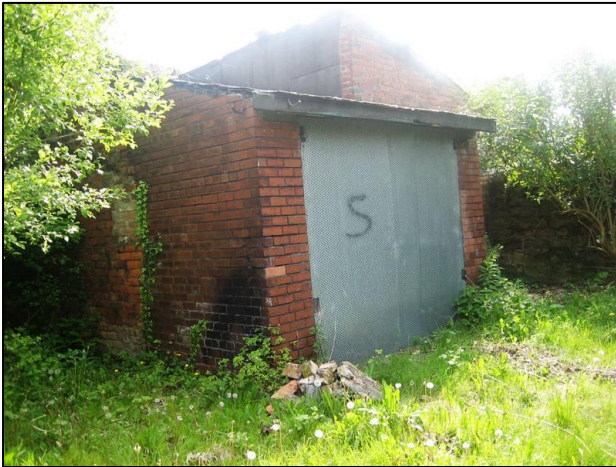
Second Building: Modern Brick Work to the front, older brick work to the rear

The second building on the site is located to the east of the plot and is positioned against the Grade II Basin Bridge and plans are to demolish this building. It appears on the OS maps between 1848 and 1893 and may have been built around the same period as the former canal office. It has been built and later altered using a variety of materials at different periods in time. A previous extensions to the building has since been removed, the reasons

for which are unknown. The use of this building is unidentified, however due to its location it can be presumed that it may have been used for storage or shelter.

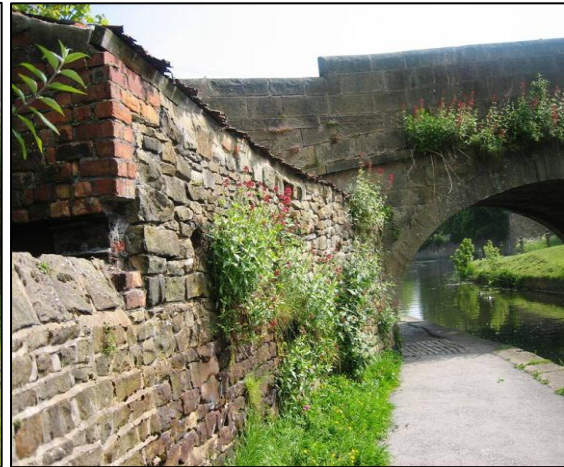
Side elevation built into the boundary wall

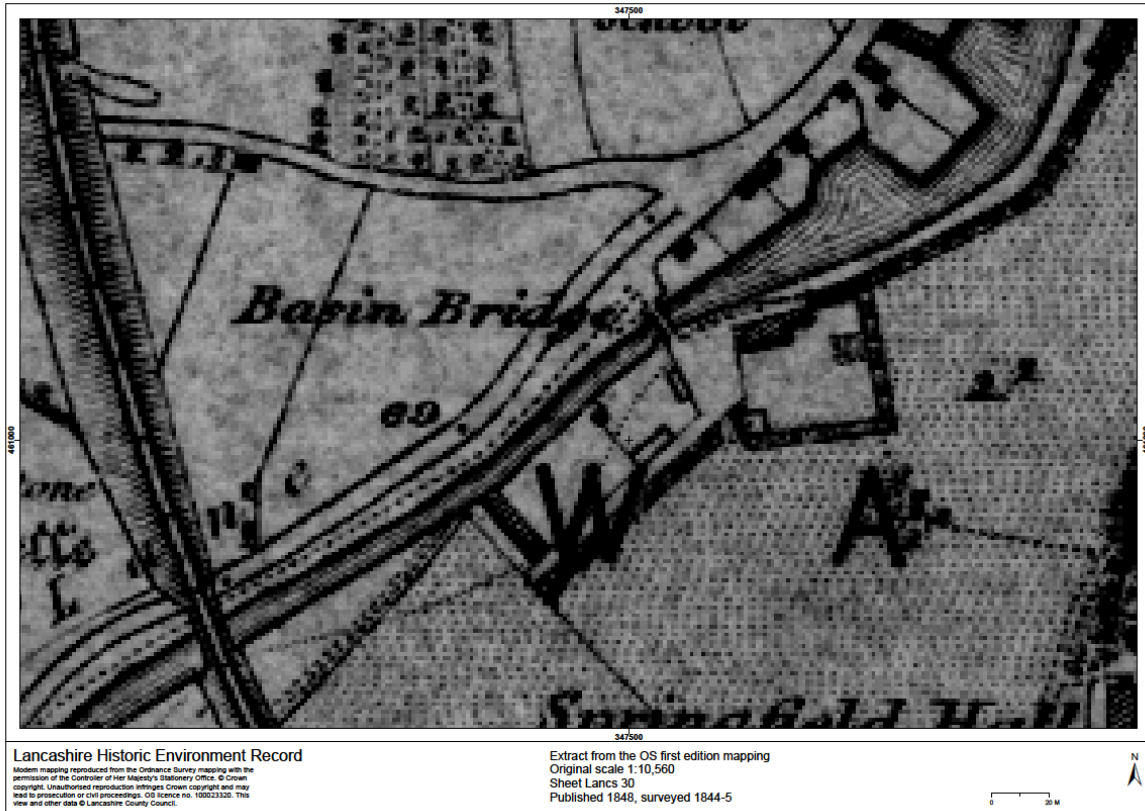
The 1848 OS map shows Basin Bridge before any buildings were built on the proposal site. North of the bridge are signs a wharf development. Not clearly shown on this copy is the location of a sandpit on the proposed site. On the opposite to the north of the proposal site is evidence of the Old Blacksmiths shop which was constructed in 1800. Also directly opposite the Aldcliffe Road site is evidence of the Packet Boat House built in 1833.
